STANDARDS & SPECIFICATIONS SITE INSPECTION REPORT LEVEL 1 (FIELD REPORT)

Project Name:	Mountain Valley Pipeline	S&S Program:	Mountain Valley Pipeline (SS027)
Inspector:	Marshall Willis	Inspection Date:	Friday, September 20, 2024
Project Contact:	Cory Chalmers Brian Clauto	Project Contact Email:	cchalmers@equitransmidstream.com bclauto@equitransmidstream.com
Spread I: Franklin County	STA 14010+58 – STA 14018+47	Site Conditions:	Dry

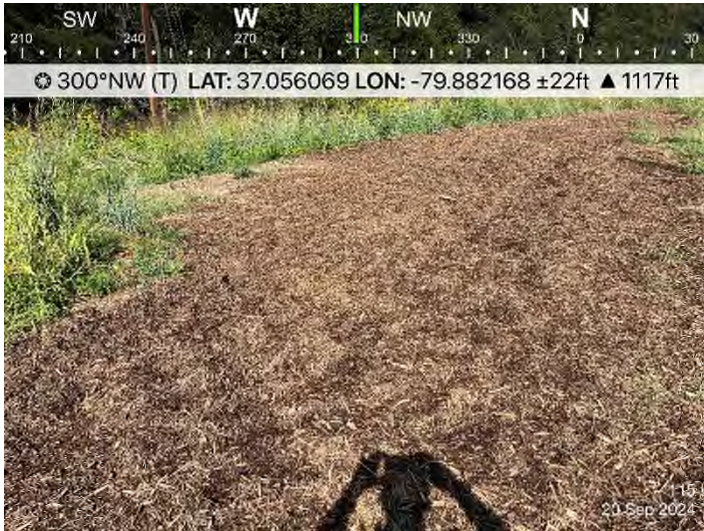
Fig. 1

STA 14013+00: Temp. controls have been removed. Mulch has been spread out from CFS.

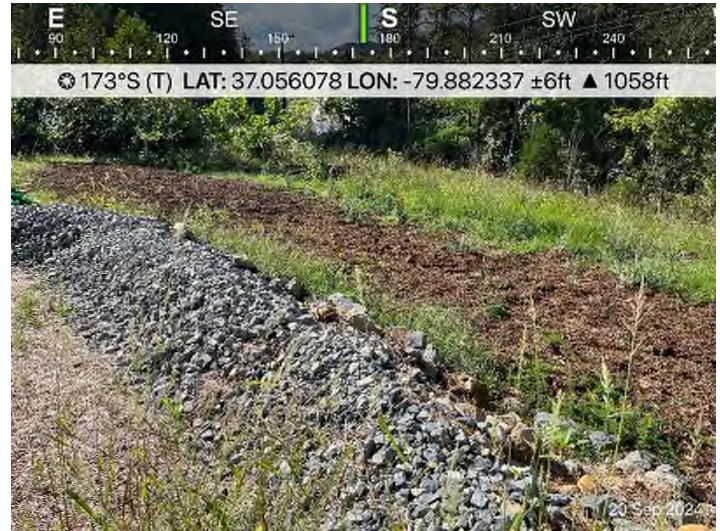
Fig. 2

STA 14014+00: Temp. controls have been removed. Mulch has been spread out from CFS.

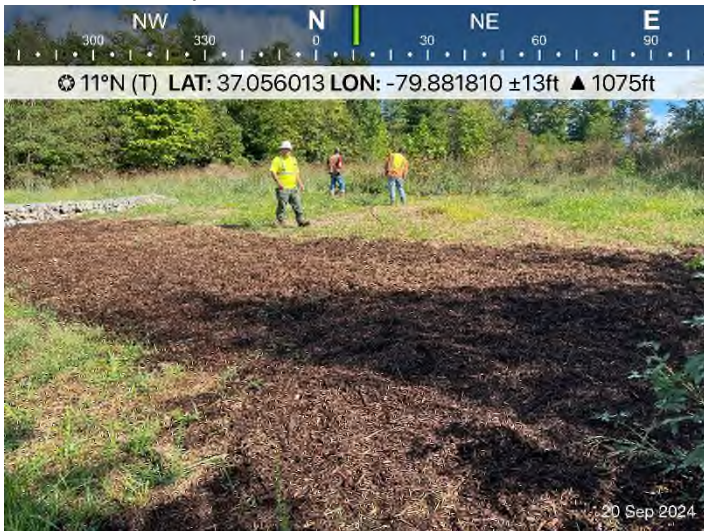
Fig. 3

STA 14015+00: Temp. controls have been removed. Mulch has been spread out from CFS.

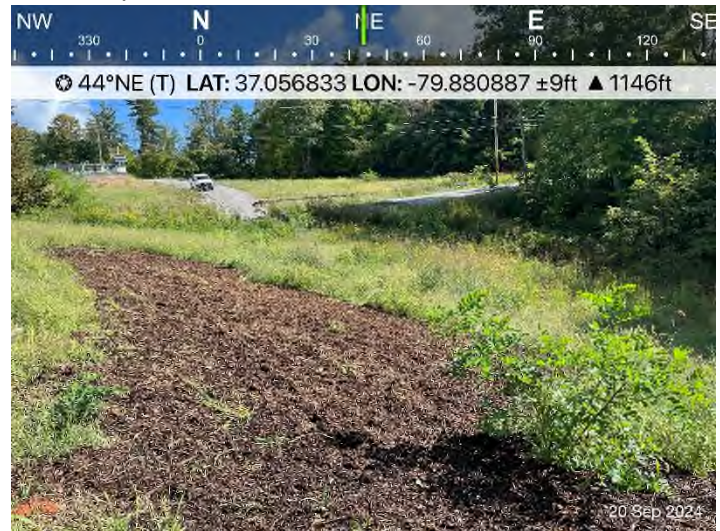
Fig. 4

STA 14016+00: Temp. controls have been removed. Mulch has been spread out from CFS.
