STANDARDS & SPECIFICATIONS SITE INSPECTION REPORT

LEVEL 1 (FIELD REPORT)

Project Name:	Mountain Valley Pipeline	S&S Program:	Mountain Valley Pipeline (SS027)
Inspector:	Marshall Willis	Inspection Date:	Wednesday, September 11, 2024
Project Contact:	Cory Chalmers Brian Clauto	Project Contact Email:	cchalmers@equitransmidstream.com bclauto@equitransmidstream.com
Spread I: Franklin County	STA 14333+27 - STA 14411+04 STA 13425+01 - STA 13437+00 STA 14009+86 - STA 14018+58 MVP-FR-306.02	Site Conditions:	Dry

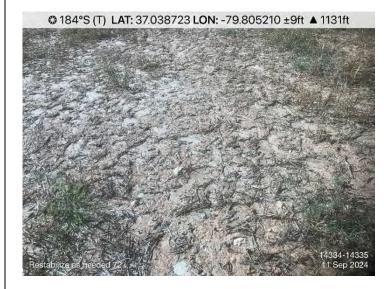
Fig. 1 **STA 14334+00 to 14337+00:** Restabilize as needed.

3. Areas of offsite sediment deposition observed?									\boxtimes				
 <u>Comments:</u> Inspected the following resources: S-A36, S-A41, S-A38 and W-DD1. Routine Maintenance: (<u>72-Hour Deadline</u> from Notification) STA 14334+00 to 14337+00: Restabilize as needed. <u>Corrective Action:</u> Maintain and install all controls per the approved S&S.

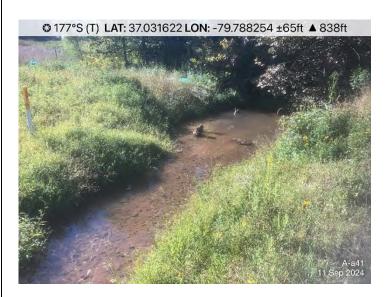
Fig. 2 **Stream S-A41:** Controls in place and functioning properly.

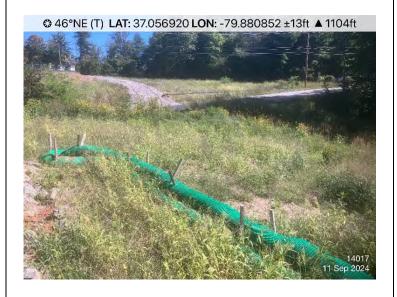
Fig. 3 **STA 14017+00:** Controls in place and functioning properly.

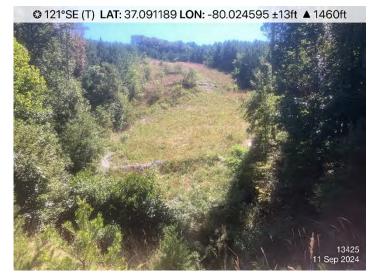
Fig. 4
STA 13425+00: Controls in place and functioning properly.
