STANDARDS & SPECIFICATIONS SITE INSPECTION REPORT

LEVEL 1 (FIELD REPORT)

Project Name:	Mountain Valley Pipeline	S&S Program:	Mountain Valley Pipeline (SS027)
Inspector:	Marshall Willis	Inspection Date:	Tuesday, September 10, 2024
Project Contact:	Cory Chalmers Brian Clauto	Project Contact Email:	cchalmers@equitransmidstream.com bclauto@equitransmidstream.com
Spread H: Franklin County	STA 13012+63 - STA 13040+00 MVP-FR-289 MVP-FR-290	Site Conditions:	Dry

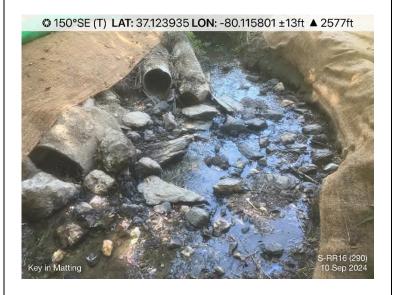
3. Areas of offsite sediment deposition observed?								\boxtimes					
Comments: Inspected the following resources: W-ST2-PEM, S-G24, S-G25 and S-RR16. Ineffective Controls: (24-Hour Deadline from Notification) - Stream S-RR16: Properly install erosion control matting along Stream S-RR16 on MVP-FR-290. Corrective Action: Maintain and install all controls per the approved S&S.

Fig. 1 Stream S-RR16: Properly install ECM.

Deadline: Within 24-Hour of Notification

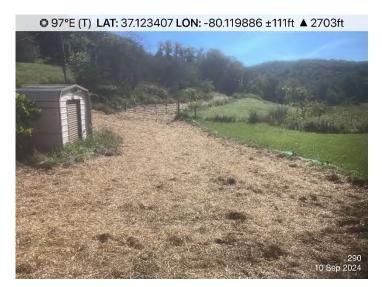
Fig. 2 MVP-FR-290: Controls in place and functioning properly.

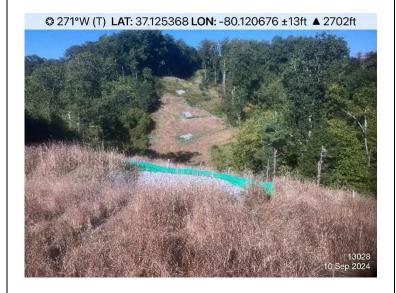
Fig. 3 **STA 13028+00:** Controls in place and functioning properly.

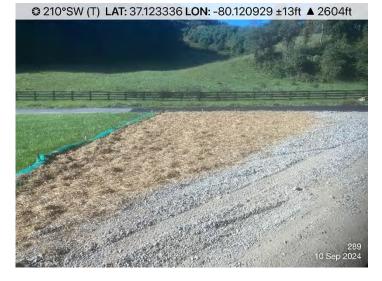
Fig. 4

MVP-FR-289: Controls in place and functioning properly.
