STANDARDS & SPECIFICATIONS SITE INSPECTION REPORT LEVEL 1 (FIELD REPORT)

Project Name:	Mountain Valley Pipeline	S&S Program:	Mountain Valley Pipeline (SS027)
Inspector:	Matthew Grant	Inspection Date:	Wednesday, September 25, 2024
Project Contact:	Cory Chalmers Brian Clauto	Project Contact Email:	cchalmers@equitransmidstream.com bclauto@equitransmidstream.com
Spread I: Franklin County	STA 13892-13889, 14521-14498 ATWS 696	Site Conditions:	Wet

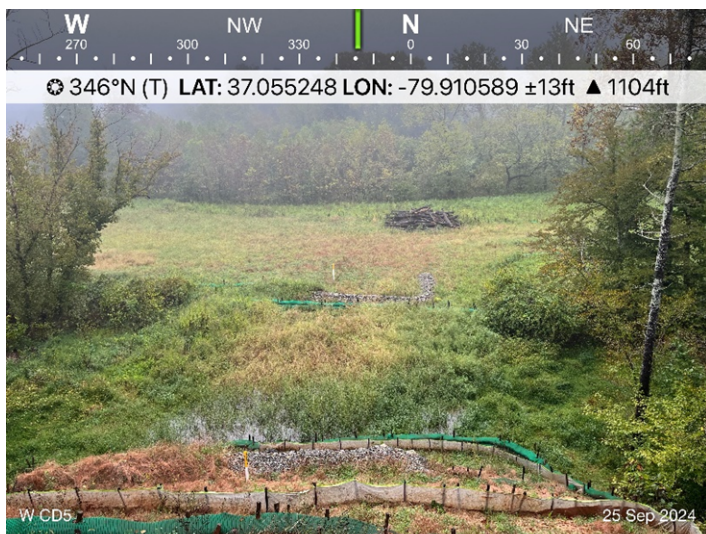
Fig. 1

Description: Designated Crossing W-CD5, slope has been repaired and additional stabilization is planned.

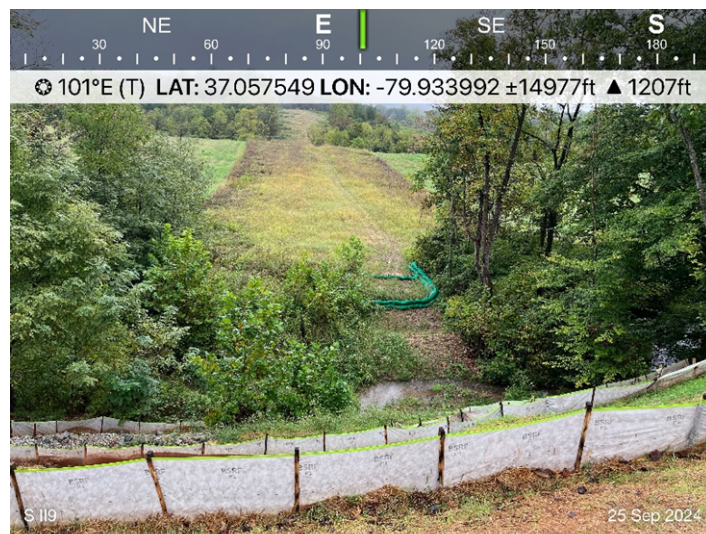
Fig. 2

Description: Designated Crossing S-II9, slope has been repaired and additional stabilization is planned.

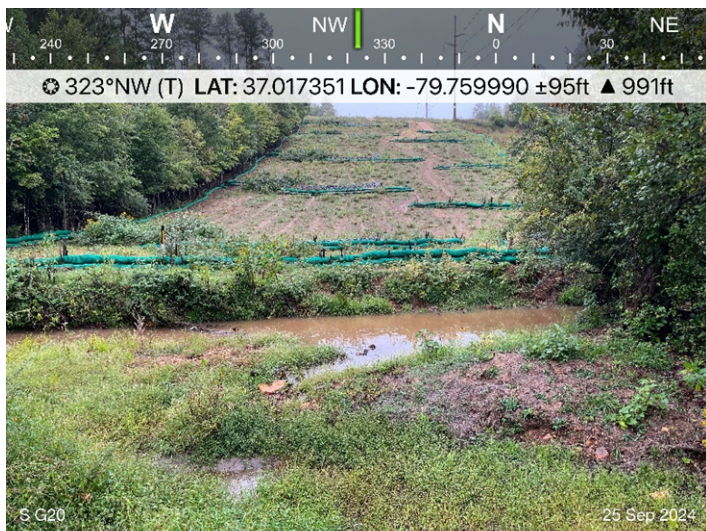
Fig. 3

Description: Designated crossing S-G20, ESC remains in place.

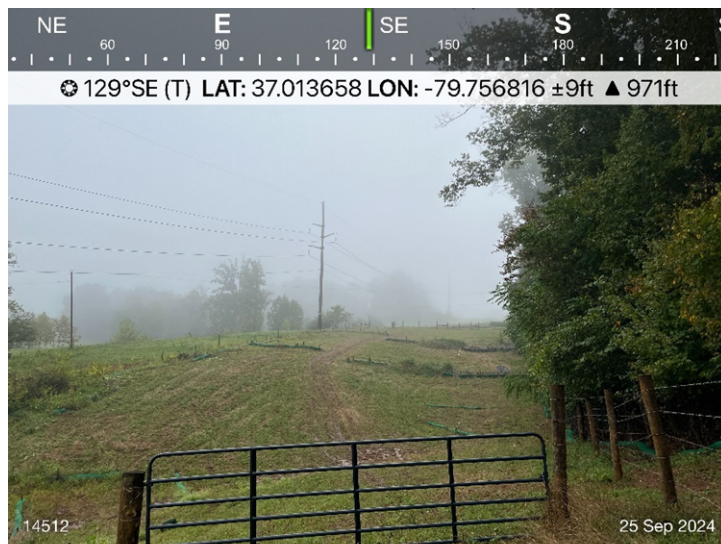
Fig. 4

Description: Sta 145212, ESC is in place.
