STANDARDS & SPECIFICATIONS SITE INSPECTION REPORT LEVEL 1 (FIELD REPORT)

Project Name:	Mountain Valley Pipeline	S&S Program:	Mountain Valley Pipeline (SS027)
Inspector:	Matthew Grant	Inspection Date:	Tuesday, September 24, 2024
Project Contact:	Cory Chalmers Brian Clauto	Project Contact Email:	cchalmers@equitransmidstream.com bclauto@equitransmidstream.com
Spread H: Roanoke County	LY049	Site Conditions:	Wet

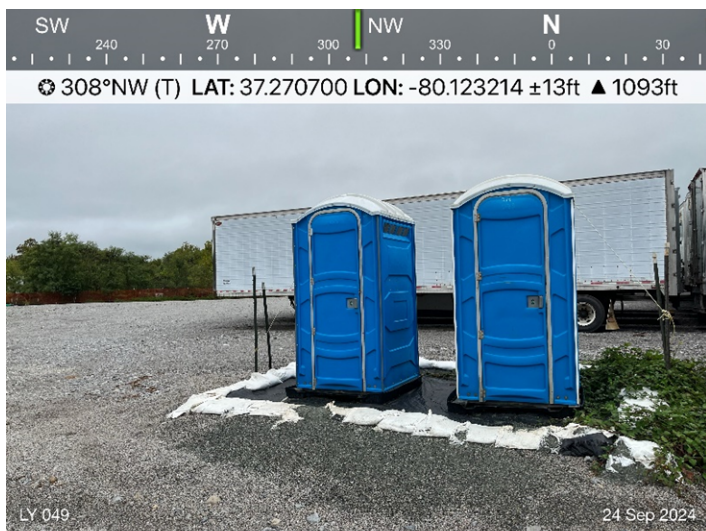
Fig. 1

Description: LY049, Porto johns remain protected.

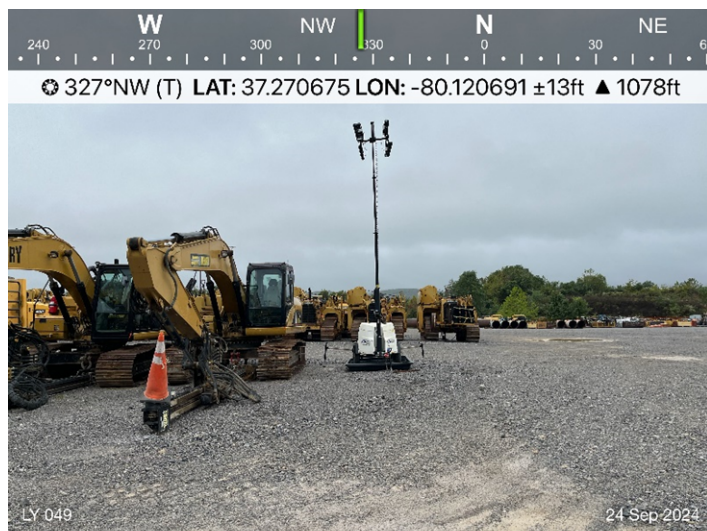
Fig. 2

Description: Secondary containment remains in place for light structures.

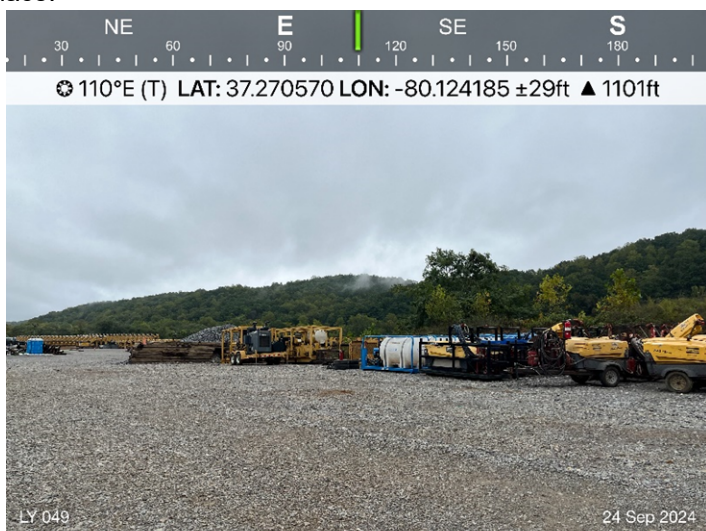
Fig. 3

Description: LY049, possible pollutant protection remains in place.

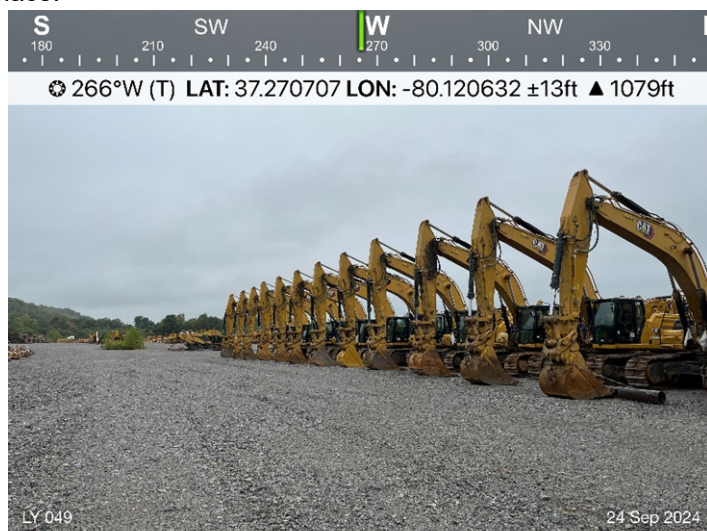
Fig. 4

Description: LY049 storage of equipment and protection is in place.
