# STANDARDS & SPECIFICATIONS SITE INSPECTION REPORT LEVEL 1 (FIELD REPORT)

Project Name:	Mountain Valley Pipeline	S&S Program:	Mountain Valley Pipeline (SS027)
Inspector:	Matthew Grant	Inspection Date:	Tuesday, September 10, 2024
Project Contact:	Cory Chalmers Brian Clauto	Project Contact Email:	cchalmers@equitransmidstream.com bclauto@equitransmidstream.com
Spread G: Montgomery County	STA 11980-11971, 11788-11790, 11767+44-11766+42, 11672-11675 MN 266, MLV 26	Site Conditions:	Wet

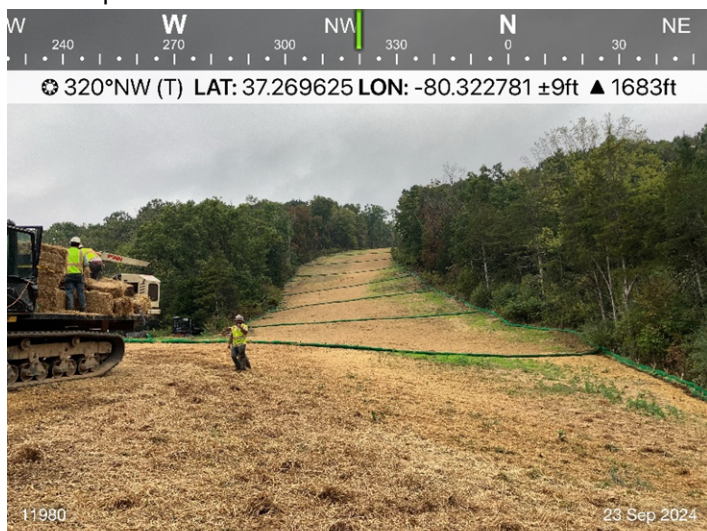
Fig. 1

Offsite sediment had been removed near Sta 11978 and the area has been seeded and mulched.

Description: Sta 11980, area has been repaired and stabilized, ESC is in place.

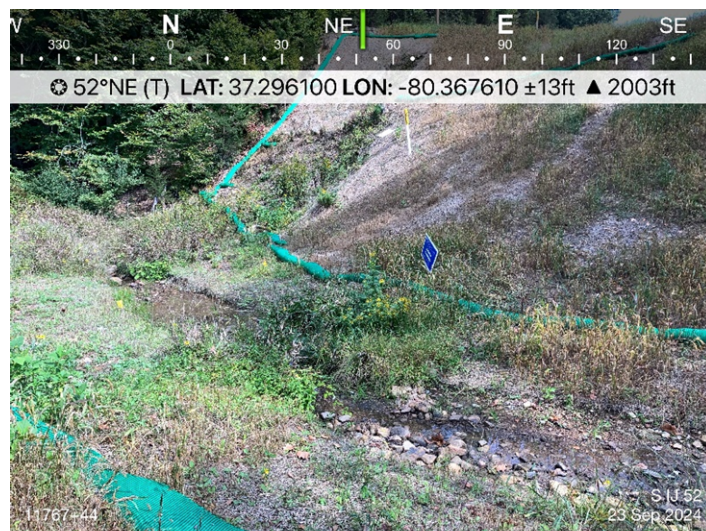
Fig. 2

Description: Designated Crossing S-IJ52, ESC is in place.

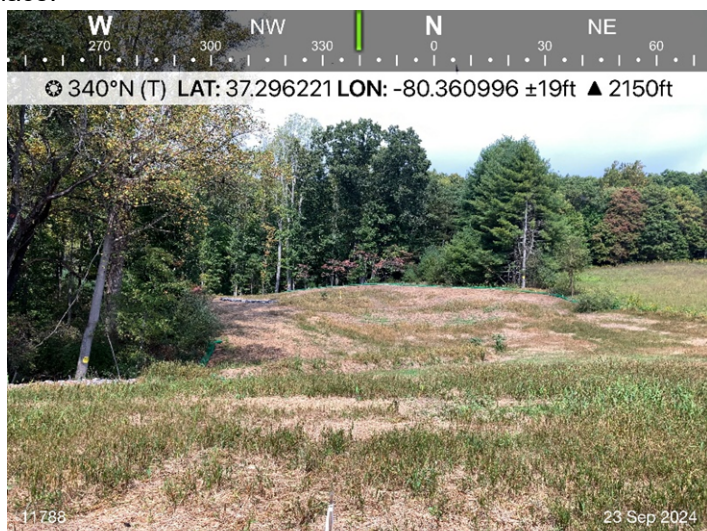
Fig. 3

Description: Sta 11788, permanent waterbars and ESC is in place.

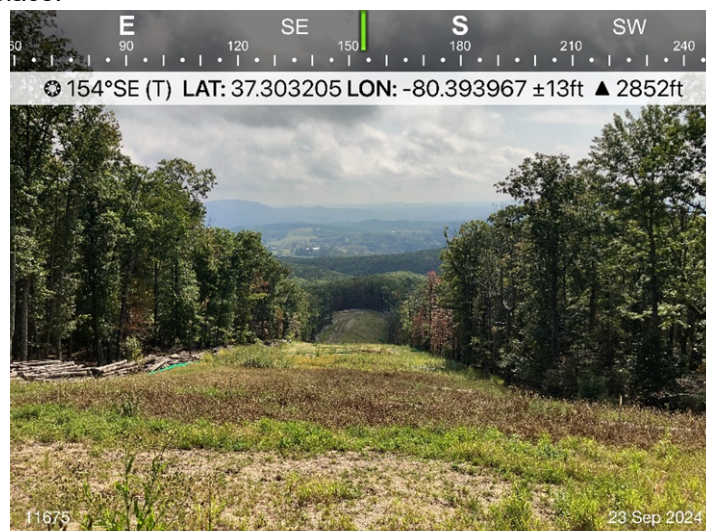
Fig. 4

Description: Sta 11675, permanent waterbars and ESC is in place.
