# STANDARDS & SPECIFICATIONS SITE INSPECTION REPORT LEVEL 1 (FIELD REPORT)

| Project Name: | Mountain Valley Pipeline | S&S Program: | Mountain Valley Pipeline (SS027) |
| Spread I:<br>Franklin County | STA 14496+69 – STA 15224+76<br>MVP-FR-317 | Site Conditions: | Rainy |

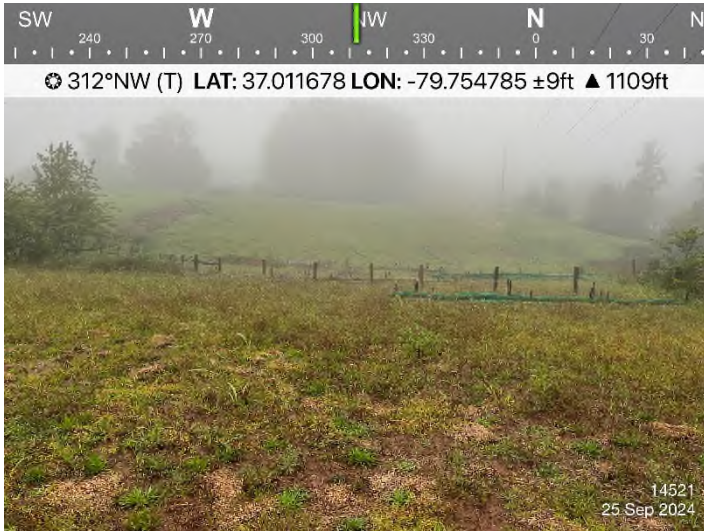
Fig. 1  
STA 14521+00: Controls in place and functioning properly.

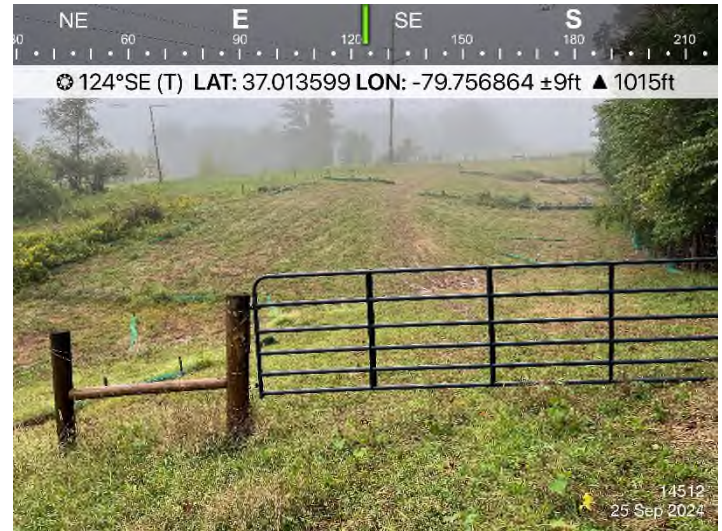
Fig. 2  
STA 14512+00: Controls in place and functioning properly.

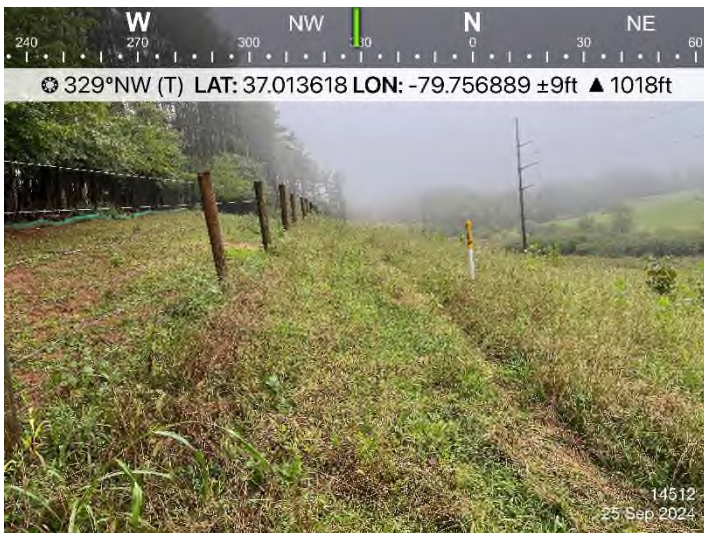
Fig. 3  
STA 14512+00: Controls in place and functioning properly.

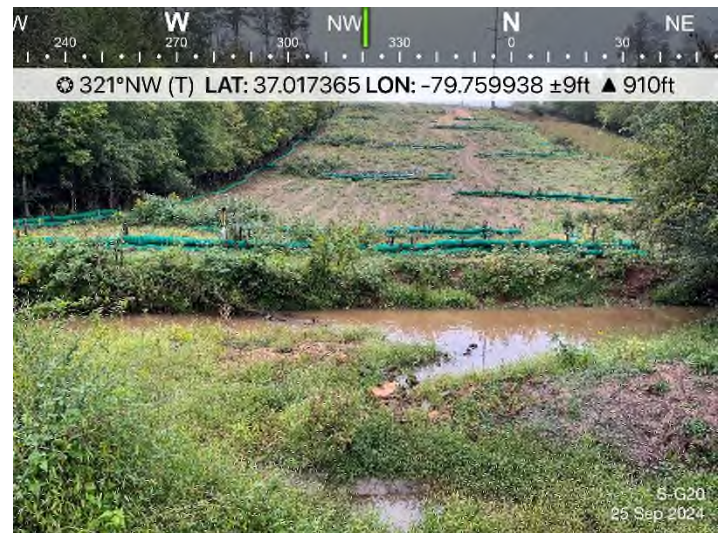
Fig. 4  
Stream S-G20: Controls in place and functioning properly.
