STANDARDS & SPECIFICATIONS SITE INSPECTION REPORT LEVEL 1 (FIELD REPORT)

Project Name:	Mountain Valley Pipeline (MVP)	S&S Program:	Mountain Valley Pipeline (SS027)
Inspector:	Marshall Willis	Inspection Date:	Monday, October 7, 2024
Project Contact:	Cory Chalmers Brian Clauto	Project Contact Email:	cchalmers@equitransmidstream.com bclauto@equitransmidstream.com
Spread H: Montgomery County	STA 12070+00 – STA 12102+70 MVP-MN-270 MVP-MN-270.01	Site Conditions:	Wet

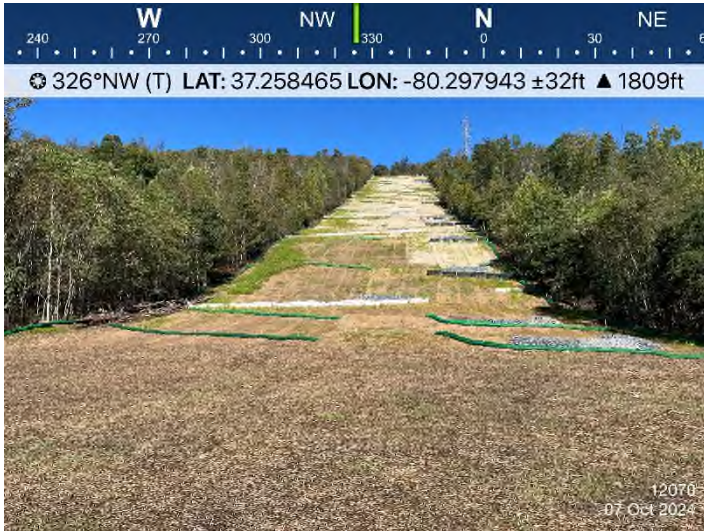
Fig. 1
STA 12070+00: Controls in place and functioning properly.

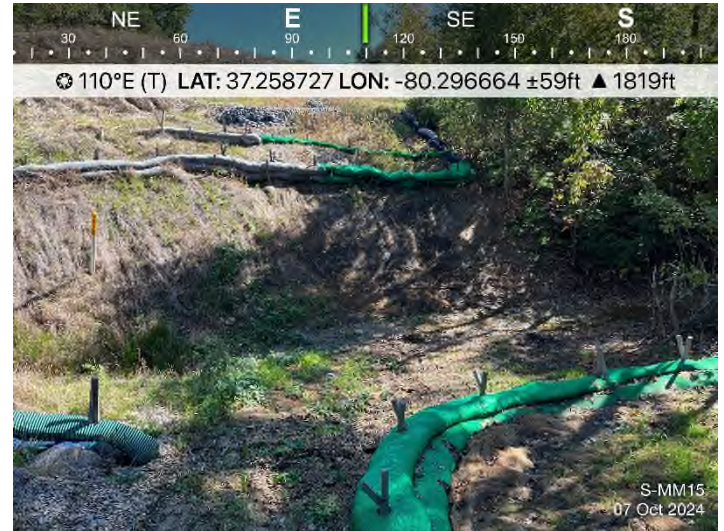
Fig. 2
Stream S-MM15: Controls in place and functioning properly.

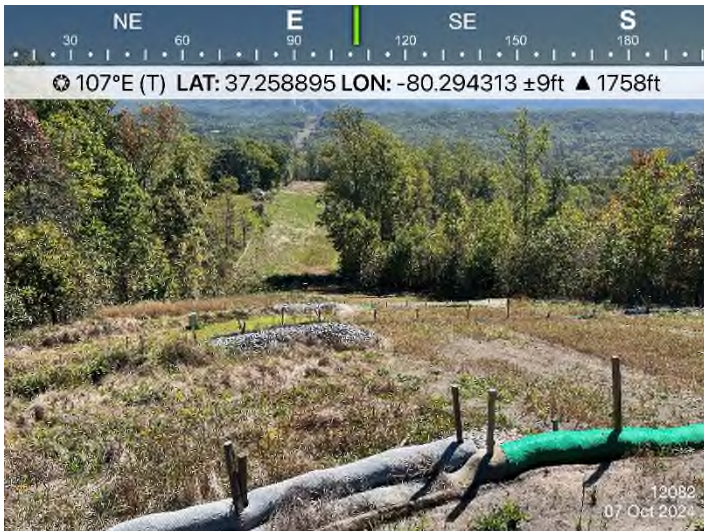
Fig. 3
STA 12082+00: Controls in place and functioning properly.

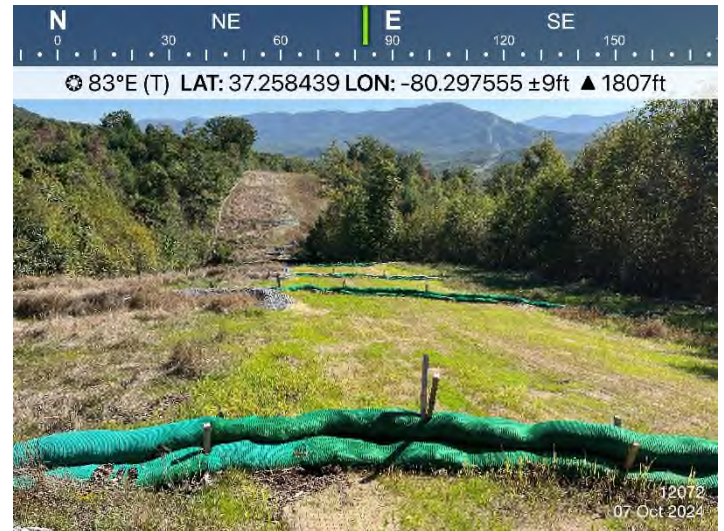
Fig. 4
STA 12072+00: Controls in place and functioning properly.
