STANDARDS & SPECIFICATIONS SITE INSPECTION REPORT LEVEL 1 (FIELD REPORT)

Project Name:	Mountain Valley Pipeline	S&S Program:	Mountain Valley Pipeline (SS027)
Inspector:	Matthew Grant	Inspection Date:	Thursday, October 17, 2024
Project Contact:	Cory Chalmers Brian Clauto	Project Contact Email:	cchalmers@equitransmidstream.com bclauto@equitransmidstream.com
Spread G: Giles County	Sta 11298-11354 ATWS 633, 633A GI 256	Site Conditions:	Dry

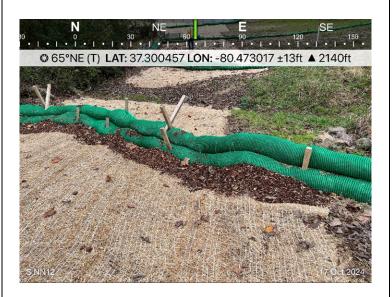
Fig. 1
Description: Designated Stream S-NN12, ESC is in place.

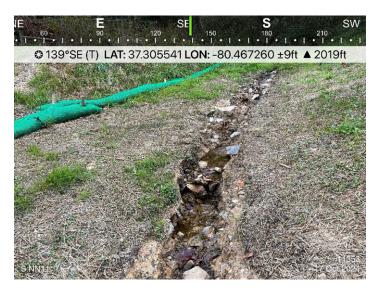
Fig. 2
Description: Designated Stream S-NN11, bed and banks of stream require repair.

3. Are	eas of of	fsite s	sediment deposition o	bserve	ed?				\boxtimes					
	<u>Comments:</u> Designated resource crossing include: S-NN12, S-NN11														
	Routine Maintenance: (<u>72-Hour Deadline</u> from Notification) - Designated Stream S-NN11, repair bed and banks of stream.														
		e Contro //A	ols: (<u>2</u>	4-Hour Deadline fron	n Notifi	cation)									
	Corrective Action: Maintain and install all controls per the approved S&S.

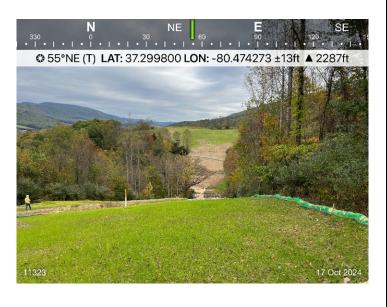
Fig. 3 Description: Sta 11323, ESC is in place.

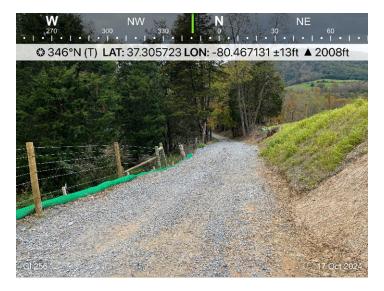
Fig. 4
Description: AR GI 256, ESC remains in place.
