STANDARDS & SPECIFICATIONS SITE INSPECTION REPORT LEVEL 1 (FIELD REPORT)

Project Name:	Mountain Valley Pipeline	S&S Program:	Mountain Valley Pipeline (SS027)
Inspector:	Marshall Willis	Inspection Date:	Friday, November 15, 2024
Project Contact:	Cory Chalmers Brian Clauto	Project Contact Email:	cchalmers@equitransmidstream.com bclauto@equitransmidstream.com
Spread I: Franklin County	STA 13540+00 – STA 13650+00 MLV-AR-30 STA 13540+00 – STA 13545+00	Site Conditions:	Wet

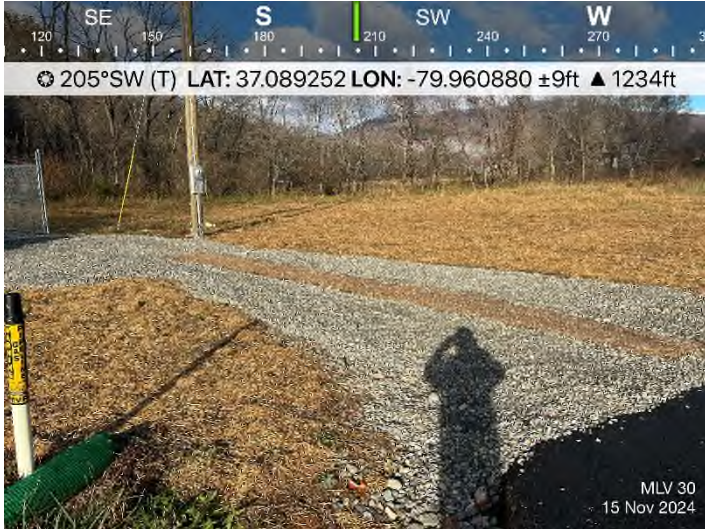
Fig. 1

MLV-AR-30: Permanent access road installed. ATWS stabilized.

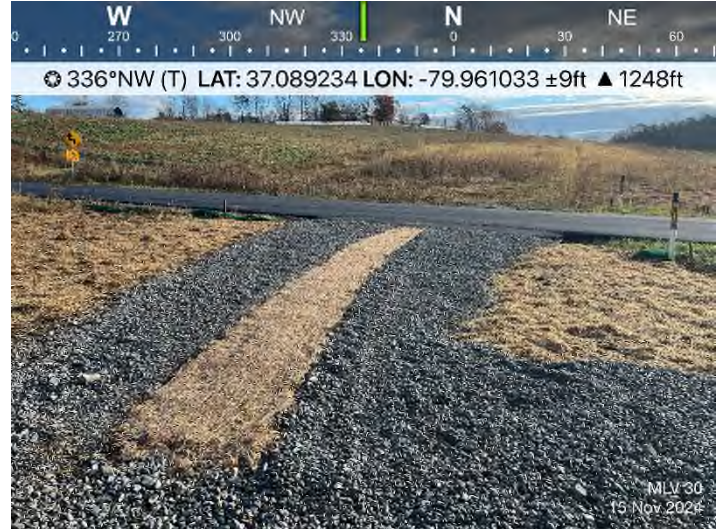
Fig. 2

MLV-AR-30: Permanent access road installed.

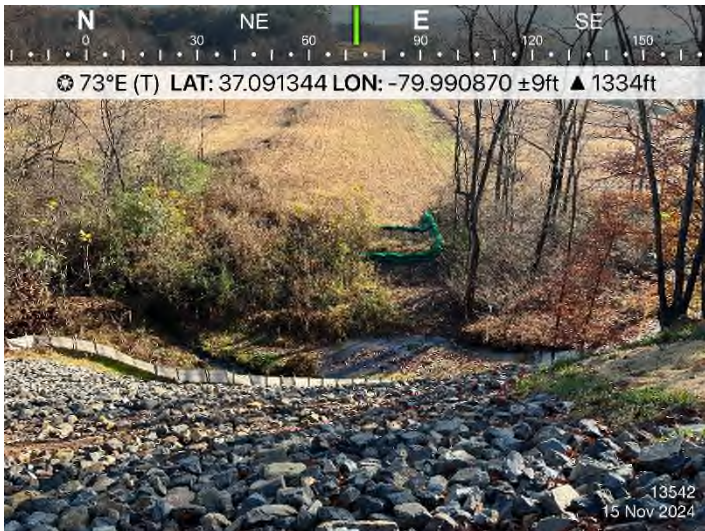
Fig. 3

STA 13542+00: Slip repair complete above S-II9.

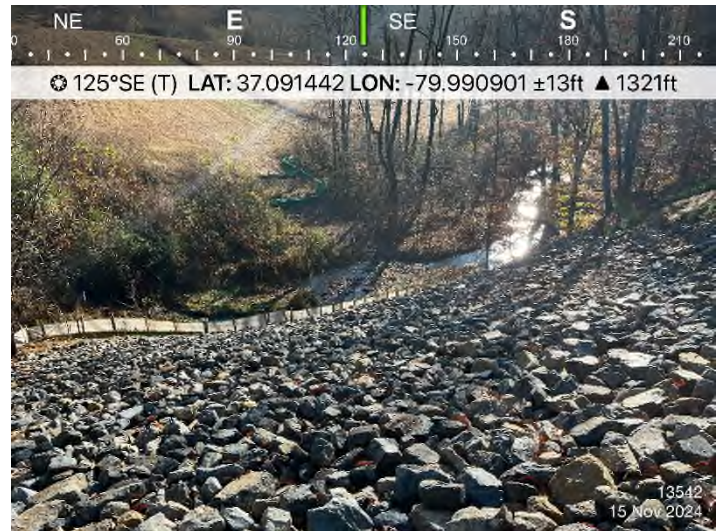
Fig. 4

STA 13542+00: Slip repair complete above S-II9.
