STANDARDS & SPECIFICATIONS SITE INSPECTION REPORT

LEVEL 1 (FIELD REPORT)

Project Name:	Mountain Valley Pipeline	S&S Program:	Mountain Valley Pipeline (SS027)			
Inspector:	Marshall Willis	Inspection Date:	Monday, November 4, 2024			
Project Contact:	Cory Chalmers Brian Clauto	Project Contact Email:	cchalmers@equitransmidstream.com bclauto@equitransmidstream.com			
Spread I: Franklin County	STA 13748+30 - STA 13811+81	Site Conditions:	Dry

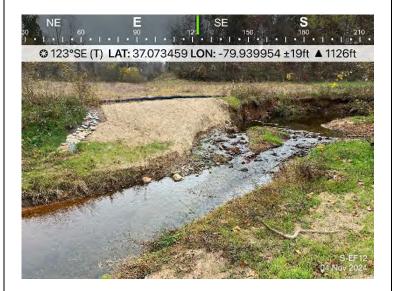
Fig. 1 **Stream S-EF12:** Controls in place and functioning properly.

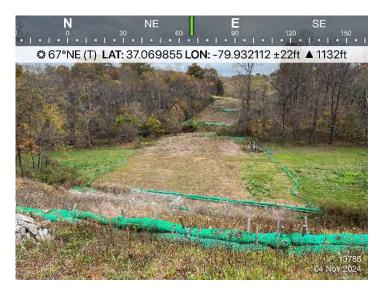
Fig. 2 **STA 13785+00:** Controls in place and functioning properly.

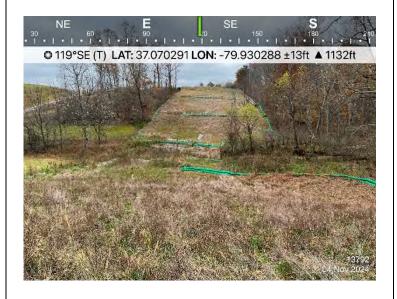
Fig. 3 **STA 13792+00:** Controls in place and functioning properly.

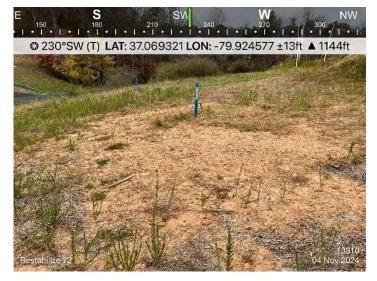
Fig. 4
STA 13810+00: Restabilization required.

3. Areas of offsite sediment deposition observed?									\boxtimes				
	Comments: Inspected the following resources: S-EF7, S-EF42, S-MM42, S-RR15, S-D23, S-D22 and S-D20. Routine Maintenance: (72-Hour Deadline from Notification) - STA 13810+00: Restabilize area. Corrective Action: Maintain and install all controls per the approved S&S.

Deadline: Within 72-Hour of Notification
