STANDARDS & SPECIFICATIONS SITE INSPECTION REPORT LEVEL 1 (FIELD REPORT)

Project Name:	Mountain Valley Pipeline	S&S Program:	Mountain Valley Pipeline (SS027)
Inspector:	Marshall Willis	Inspection Date:	Thursday, October 24, 2024
Project Contact:	Cory Chalmers Brian Clauto	Project Contact Email:	cchalmers@equitransmidstream.com bclauto@equitransmidstream.com
Spread H: Franklin County	STA 13012+63 – STA 13062+00 MVP-FR-290	Site Conditions:	Dry

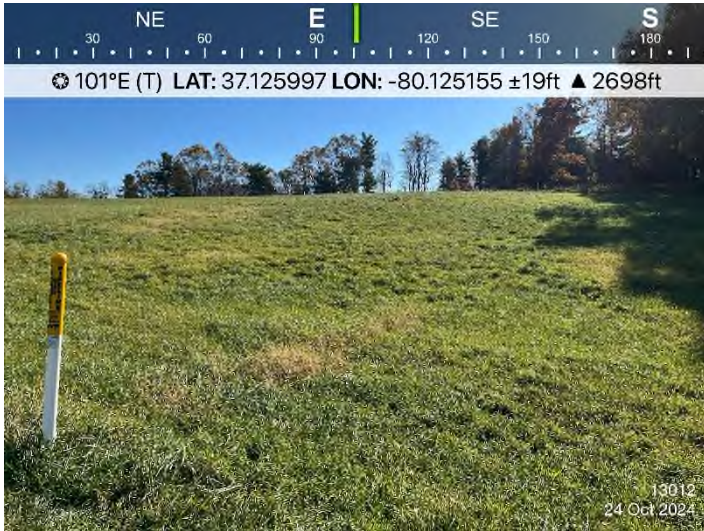
Fig. 1
STA 13012+00: Controls in place and functioning properly.

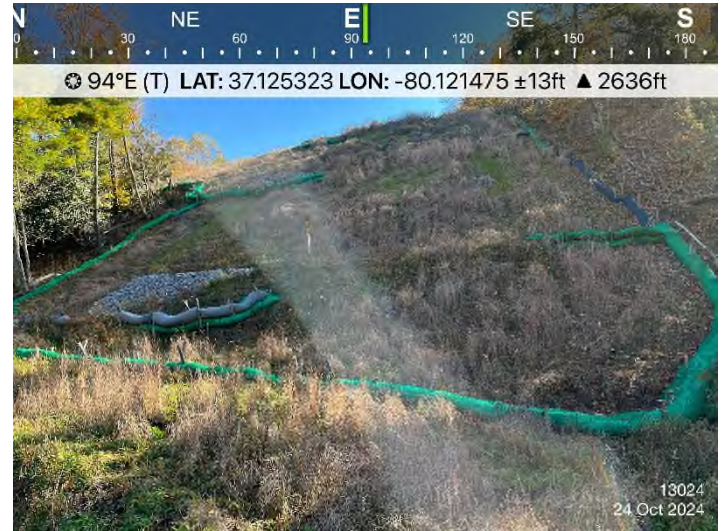
Fig. 2
STA 13024+00: Controls in place and functioning properly.

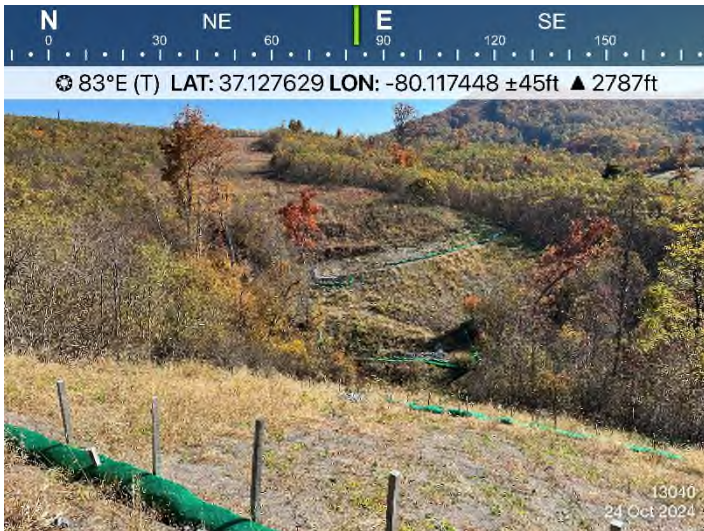
Fig. 3
STA 13040+00: Controls in place and functioning properly.

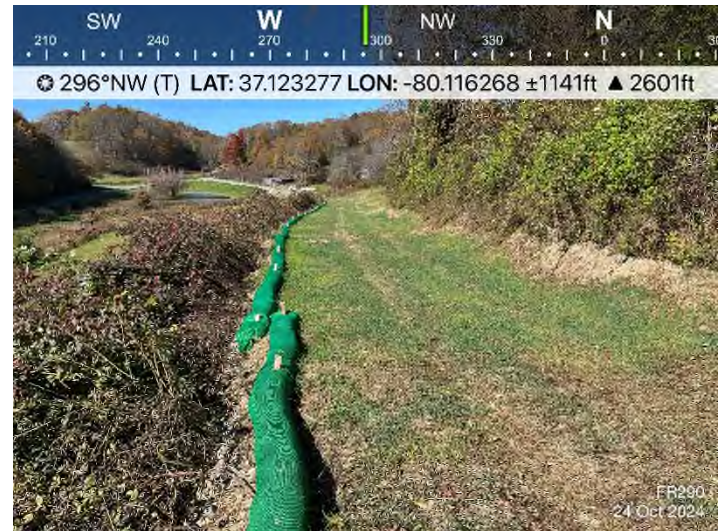
Fig. 4
MVP-FR-290: Controls in place and functioning properly.
