STANDARDS & SPECIFICATIONS SITE INSPECTION REPORT LEVEL 1 (FIELD REPORT)

Project Name:	Mountain Valley Pipeline	S&S Program:	Mountain Valley Pipeline (SS027)
Inspector:	Matthew Grant	Inspection Date:	Wednesday, November 13, 2024
Project Contact:	Cory Chalmers Brian Clauto	Project Contact Email:	brian.clauto@eqt.com cory.chalmers@eqt.com
Spread H: Roanoke County	RO 283 ATWS 1326, 1304 Sta 12606-12640	Site Conditions:	Dry

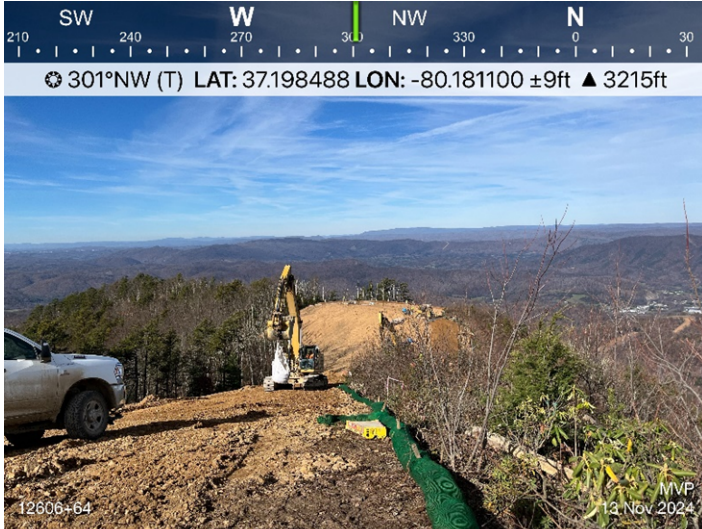
Fig. 1

Description: Sta 12606+64 active grading, ESC is in place.

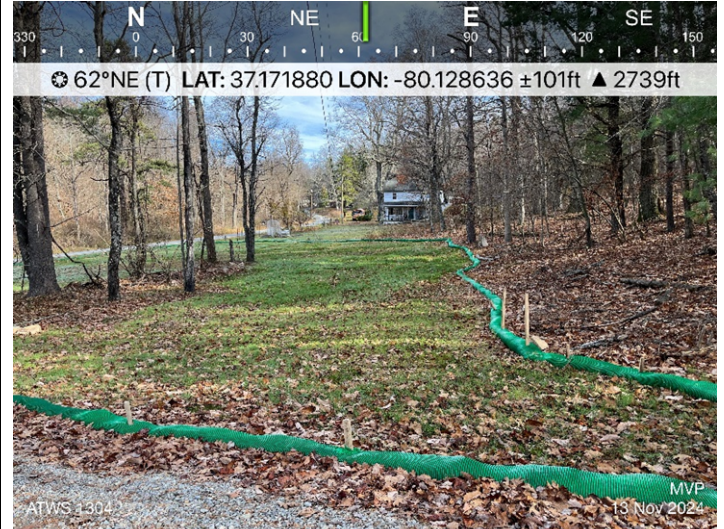
Fig. 2

Description: ATWS 1304, ESC remains in place.

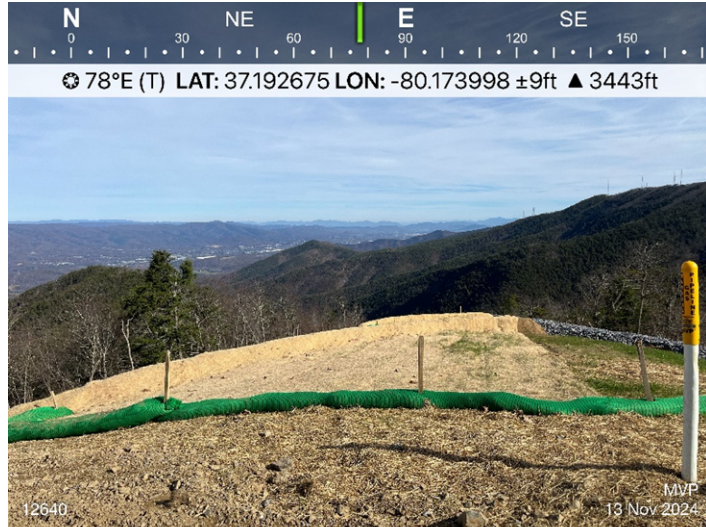
Fig. 3

Description: Sta 12640, ESC and stabilization in place.

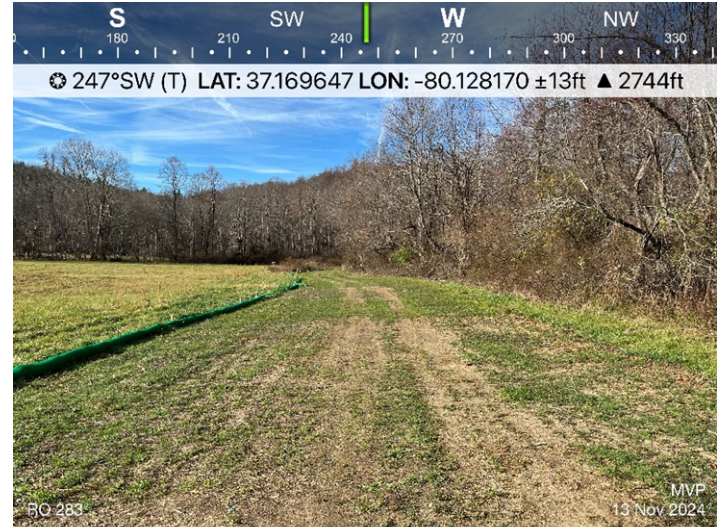
Fig. 4

Description: RO283, ESC remains in place.
