STANDARDS & SPECIFICATIONS SITE INSPECTION REPORT LEVEL 1 (FIELD REPORT)

Project Name:	Mountain Valley Pipeline	S&S Program:	Mountain Valley Pipeline (SS027)
Inspector:	Matthew Grant	Inspection Date:	Wednesday, November 13, 2024
Project Contact:	Cory Chalmers Brian Clauto	Project Contact Email:	brian.clauto@eqt.com cory.chalmers@eqt.com
Spread G: Montgomery County	Sta 11670-11767+44 MLV 26	Site Conditions:	Wet

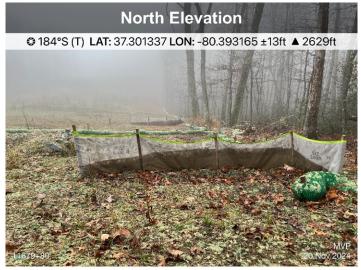
Fig. 1

Description: Sta 11679+80 silt fence has hole.

3. Areas	s of offsite	sediment deposition	n observe	ed?				\boxtimes					
	Comments: Designated resource crossing inspected included: S-MN21, S-MN22, S-EF65, S-EF62, S-IJ52 ECD's remain in place at crossings. Routine Maintenance: (72-Hour Deadline from Notification) - Sta 11679+80, silt fence has hole and requires repair. Ineffective Controls: (24-Hour Deadline from Notification) - N/A Corrective Action: Maintain and install all controls per the approved S&S.

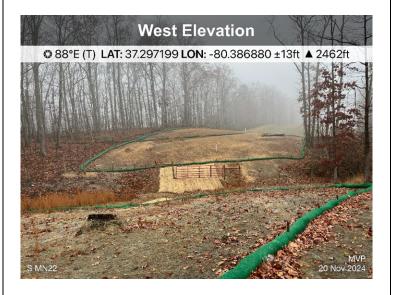
place.

Fig. 3
Description: Designated stream S-MN22, ESC remains in

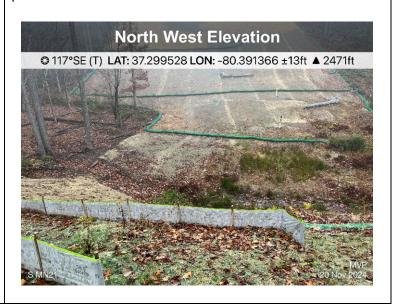
Fig. 2
Description: Designated Stream S-MN21, ECD's remain in place.

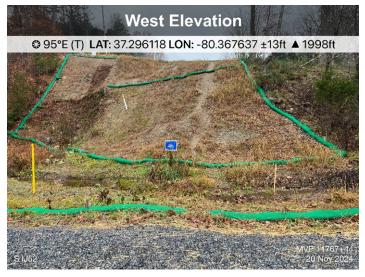
Fig. 4
Description: Designated stream S-IJ 52, ESC remains in place.
