# STANDARDS & SPECIFICATIONS SITE INSPECTION REPORT LEVEL 1 (FIELD REPORT)

| Project Name: | Mountain Valley Pipeline | S&S Program: | Mountain Valley Pipeline (SS027) |
| Inspector: | Matthew Grant | Inspection Date: | Wednesday, November 13, 2024 |
| Spread G:<br>Montgomery County | Sta 11614+20-11600, 11979<br>ATWS 1057<br>MN 266 | Site Conditions: | Dry |

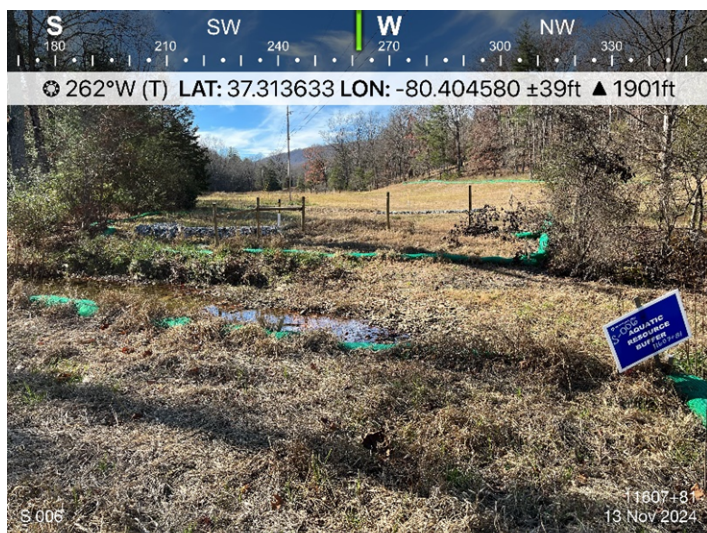
Fig. 1

Description: Designated Stream S-006, ECD's remain in place.

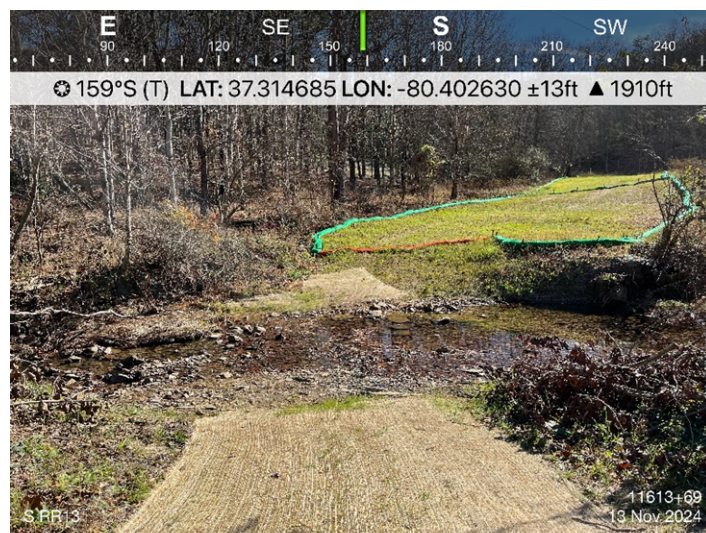
Fig. 2

Description: Designated Stream S-RR13, ECD's remain in place.

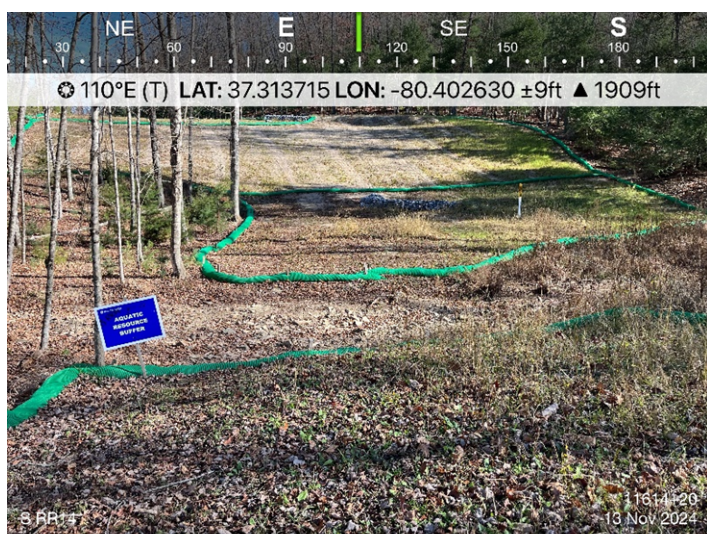
Fig. 3

Description: Designated stream S-RR14, ESC remains in place.

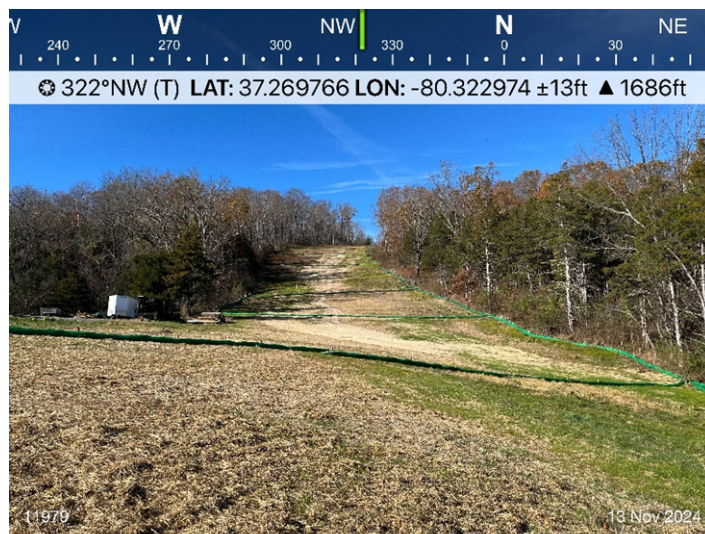
Fig. 4

Description: Sta 11979, ESC remains in place.
