## STANDARDS & SPECIFICATIONS SITE INSPECTION REPORT

**LEVEL 1 (FIELD REPORT)**

Project Name:	Mountain Valley Pipeline	S&S Program:	Mountain Valley Pipeline (SS027)
Inspector:	Marshall Willis, Matthew Grant, Zack Robinson, John McCutcheon	Inspection Date:	Wednesday, December 11, 2024
Project Contact:	Cory Chalmers Brian Clauto	Project Contact Email:	cchalmers@equitransmidstream.com bclauto@equitransmidstream.com
Spread I: Franklin County Pittslyvania County	MVP-MLV-AR-32 MVP-MLV-AR-33 MVP-MLV-AR-34 STA 14223+00 – 14249+00	Site Conditions:	Rainy

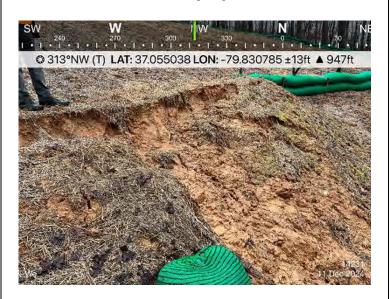
Fig. 1 STA 14231+00: Perm. WB sloughing.

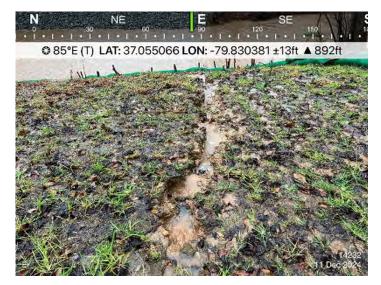
Fig. 2 STA 14232+00: Erosion occurring above S-C19.

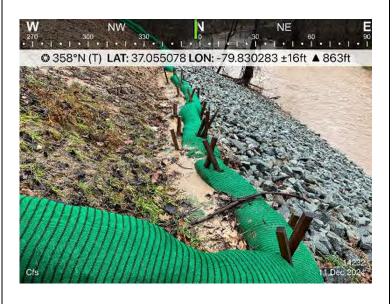
Fig. 3 **STA 14232+00:** CFS full above S-C19.

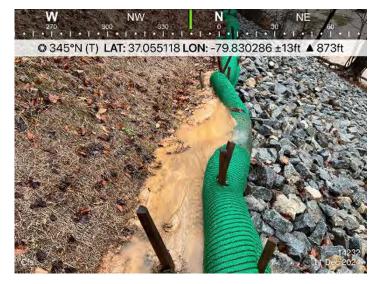
Fig. 3 **STA 14232+00:** CFS full above S-C19.
