STANDARDS & SPECIFICATIONS SITE INSPECTION REPORT

LEVEL 1 (FIELD REPORT)

Project Name:	Mountain Valley Pipeline	S&S Program:	Mountain Valley Pipeline (SS027)			
Inspector:	Marshall Willis	Inspection Date:	Wednesday, November 20, 2024			
Project Contact:	Cory Chalmers Brian Clauto	Project Contact Email:	cchalmers@equitransmidstream.com bclauto@equitransmidstream.com Wet			
Spread H: Franklin County	STA 12807+43 - STA 12866+36 MVP-RO-283	Site Conditions:

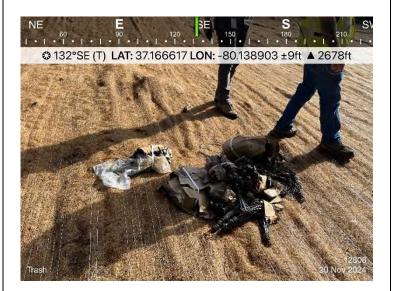
Fig. 1 STA 12808+00: Consolidate construction materials.

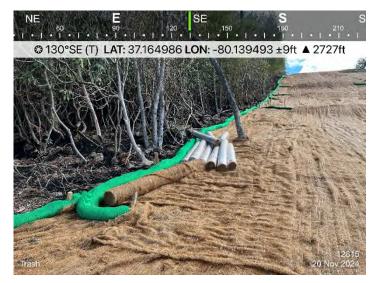
Fig. 2 STA 12815+00: Consolidate construction materials.

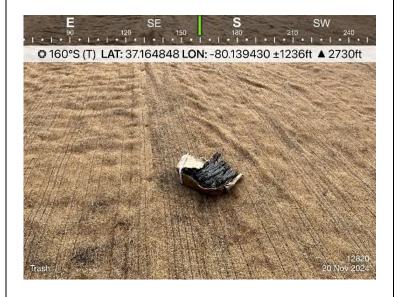
Fig. 3 **STA 12820+00:** Consolidate construction materials.

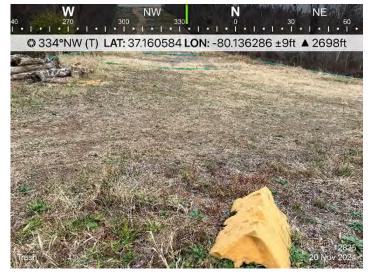
Fig. 4 STA 12835+00: Remove damage wattles and debris.
