## STANDARDS & SPECIFICATIONS SITE INSPECTION REPORT

**LEVEL 1 (FIELD REPORT)**

Project Name:	Mountain Valley Pipeline	S&S Program:	Mountain Valley Pipeline (SS027)			
Inspector:	Marshall Willis	Inspection Date:	Monday, December 23, 2024			
Project Contact:	Cory Chalmers Brian Clauto	Project Contact Email:	cchalmers@equitransmidstream.com bclauto@equitransmidstream.com			
Spread I: Franklin County	STA 13435+00 - 13450+00 STA 13540+00 - 13543+00 STA 13562+63 - 13575+21 MVP-FR-293.02	Site Conditions:	Frozen

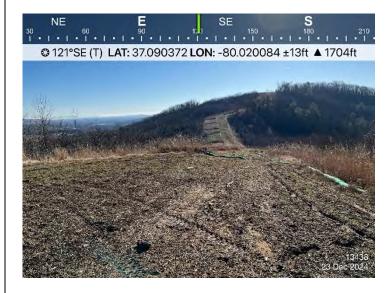
Fig. 1

STA 13438+00: Controls in place and functioning properly.

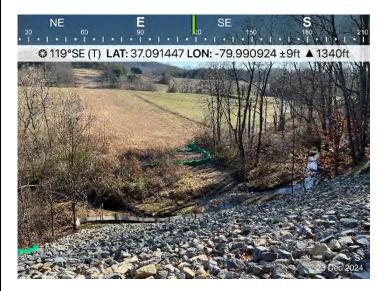
Fig. 2 **Stream S-II9:** Controls in place and functioning properly.

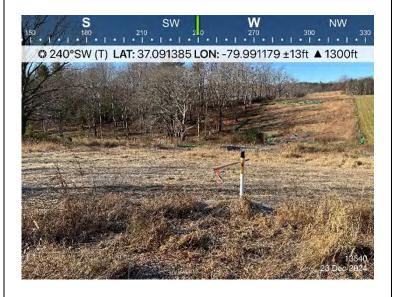
Fig. 3 **STA 13718+00:** Controls in place and functioning properly.

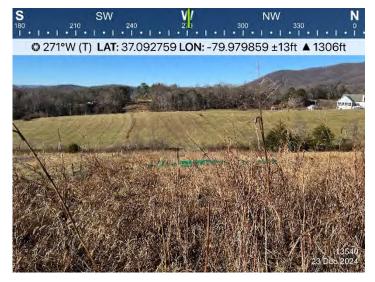
Fig. 4 STA 13575+00: Controls in place and functioning properly.
