## STANDARDS & SPECIFICATIONS SITE INSPECTION REPORT

**LEVEL 1 (FIELD REPORT)**

Project Name:	Mountain Valley Pipeline	S&S Program:	Mountain Valley Pipeline (SS027)
Inspector:	Marshall Willis	Inspection Date:	Thursday, December 19, 2024
Project Contact:	Cory Chalmers Brian Clauto	Project Contact Email:	cchalmers@equitransmidstream.com bclauto@equitransmidstream.com
Spread I: Franklin County	STA 14454+22 - 14546+75 MVP-FR-317 MVP-FR-317.01	Site Conditions:	Dry

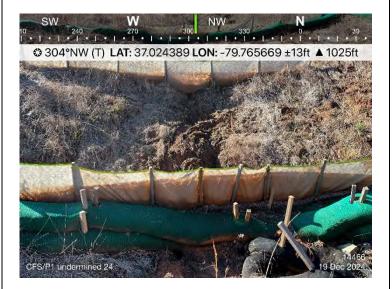
Fig. 1

STA 14466+00: CFS and P1 undermined in several locations.

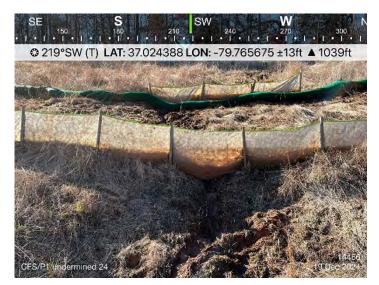
Fig. 2

STA 14466+00: Repair and restabilize slope.

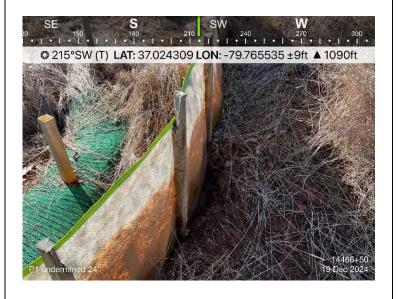
Fig. 3

STA 14466+50: CFS undermined.

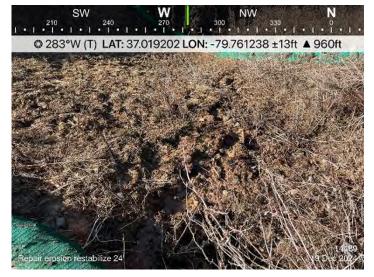
Fig. 4

STA 14489+00: Repair and restabilize slope.
