## STANDARDS & SPECIFICATIONS SITE INSPECTION REPORT

**LEVEL 1 (FIELD REPORT)**

Project Name:	Mountain Valley Pipeline	S&S Program:	Mountain Valley Pipeline (SS027)			
Inspector:	Marshall Willis	Inspection Date:	Tuesday, December 17, 2024			
Project Contact:	Cory Chalmers Brian Clauto	Project Contact Email:	cchalmers@equitransmidstream.com bclauto@equitransmidstream.com			
Spread I: Franklin County	STA 13644+82 - 13748+30	Site Conditions:	Wet

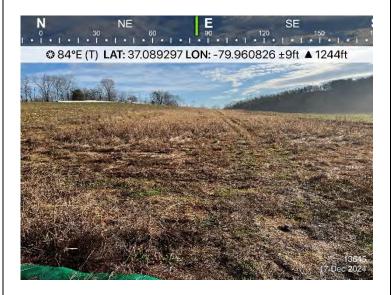
Fig. 1

**STA 13645+00:** Controls in place and functioning properly.

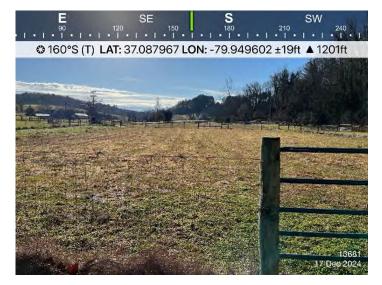
Fig. 2 **STA 13681+00:** Controls in place and functioning properly.

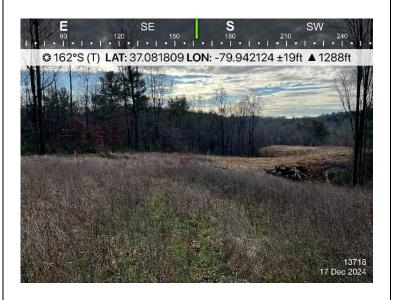
Fig. 3 **STA 13718+00:** Controls in place and functioning properly.

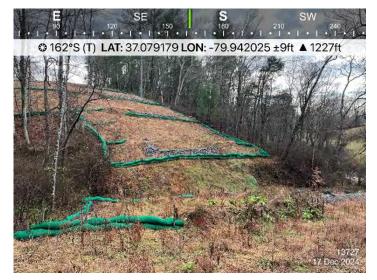
Fig. 4 STA 13727+00: Controls in place and functioning properly.
