STANDARDS & SPECIFICATIONS SITE INSPECTION REPORT

LEVEL 1 (FIELD REPORT)

Project Name:	Mountain Valley Pipeline	S&S Program:	Mountain Valley Pipeline (SS027)			
Inspector:	Marshall Willis	Inspection Date:	Friday, January 3, 2025			
Project Contact:	Cory Chalmers Brian Clauto	Project Contact Email:	cchalmers@equitransmidstream.com bclauto@equitransmidstream.com			
Spread H: Montgomery County	STA 12153+28 - 12190+85 MVP-MN-273 MVP-MN-274	Site Conditions:	Dry

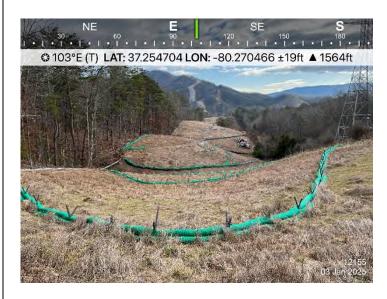
Fig. 1

STA 12155+00: Controls in place and functioning properly.

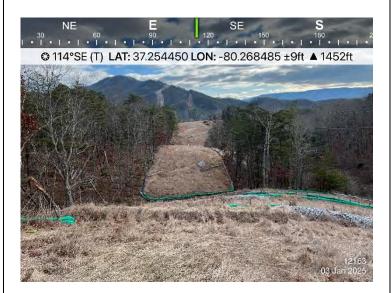
Fig. 2

STA 12163+00: Controls in place and functioning properly.

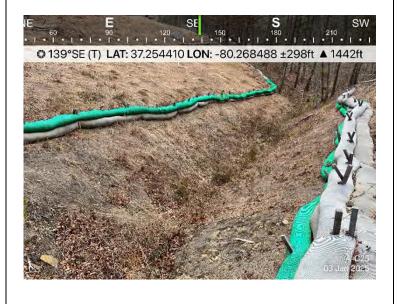
Fig. 3

Stream S-C25: Controls in place and functioning properly.

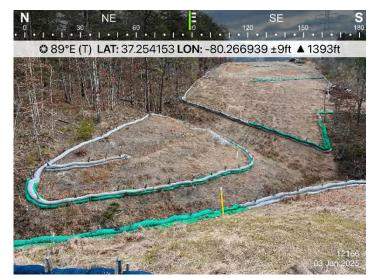
Fig. 4

STA 12166+00: Controls in place and functioning properly.
