STANDARDS & SPECIFICATIONS SITE INSPECTION REPORT

Project Name:	Mountain Valley Pipeline	S&S Program:	Mountain Valley Pipeline (SS027)			
Inspector:	Marshall Willis	Inspection Date:	Monday, December 16, 2024			
Project Contact:	Cory Chalmers Brian Clauto	Project Contact Email:	cchalmers@equitransmidstream.com bclauto@equitransmidstream.com			
Spread H: Franklin County	STA 13140+00 - 13197+55 MVP-FR-292 MVP-FR-292.01	Site Conditions:	Rainy

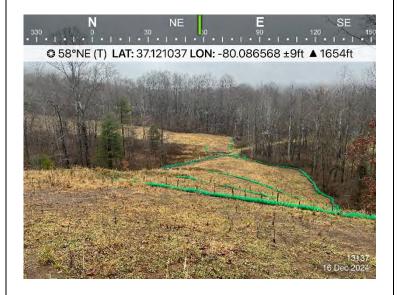
Fig. 1

STA 13137+00: Controls in place and functioning properly.

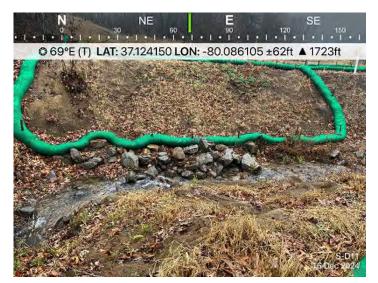
Fig. 2 **Stream S-D11:** Controls in place and functioning properly.

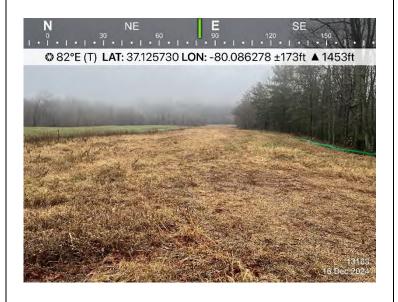
Fig. 3 **STA 13163+00:** Controls in place and functioning properly.

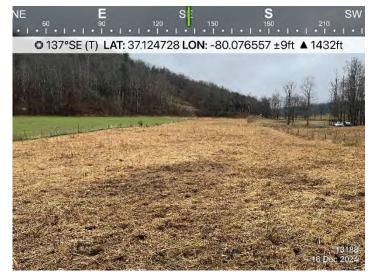
Fig. 4
STA 13188+00: Controls in place and functioning properly.
