STANDARDS & SPECIFICATIONS SITE INSPECTION REPORT LEVEL 1 (FIELD REPORT)

Project Name:	Mountain Valley Pipeline	S&S Program:	Mountain Valley Pipeline (SS027)
Inspector:	Matthew Grant	Inspection Date:	Monday, January 27, 2025
Project Contact:	Cory Chalmers Brian Clauto	Project Contact Email:	brian.clauto@eqt.com cory.chalmers@eqt.com
Spread G: Giles County Craig County	Sta 10975+68-1092+68, 10880, 10802+44, 11158+59 ATWS 1331, 471, 464 GI 241.02	Site Conditions:	Dry

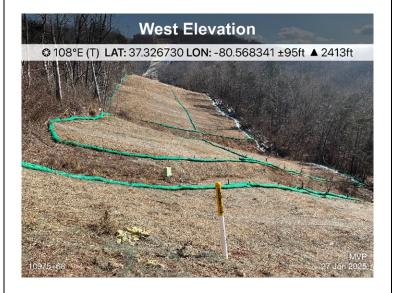
Fig. 1 Sta 10975: ECD's remain in place.

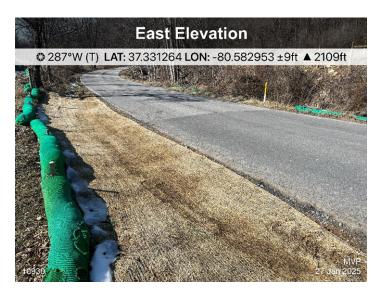
Fig. 2 Sta 10930: Roadside ditch is stabilized and controls remain in place.

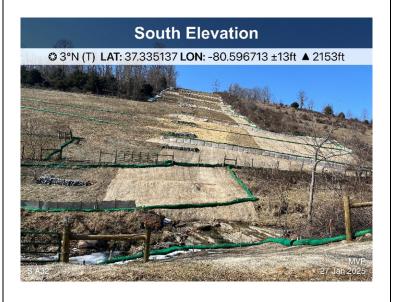
Fig. 3
Designated stream S-A32, ESC remains in place.

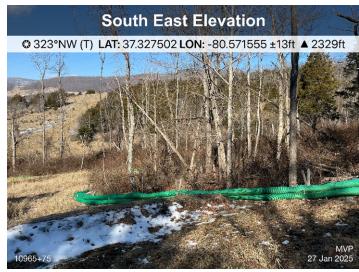
Fig. 4
Sta 10965+75, Karsts feature remains protected ESC remains in place.
