Project Name:	Mountain Valley Pipeline	Inspector: M. Willis	Matthew Grant
Inspection Date:	Wednesday, February 26, 2025	Project Contact:	Brian Clauto
Spread H: Montgomery	Sta 12071-12188 MN270, MN 274 ATWS 1168 1167, 1163, 1162, 701, 703	Weather:	Dry

FIELD INSPECTION PHOTO LOG

Project Name: Mountain Valley Pipeline Date: Wednesday, February 26, 2025

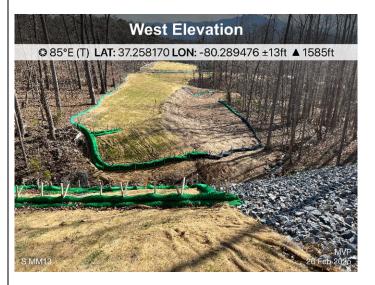
Figure 2: Designated crossing S-MM13, ESC's remains in place.

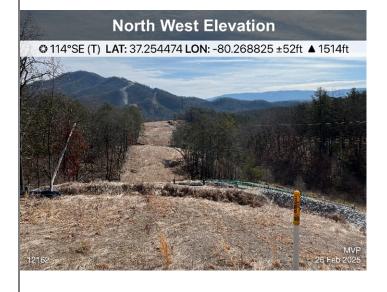
Figure 3: STA 12162, area is stabilized.

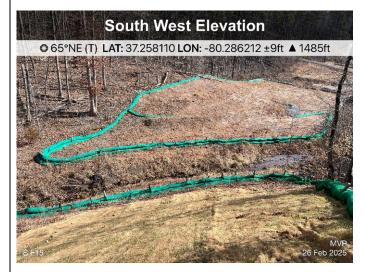
Figure 4: Designated crossing S-F15, ESC's remains in place.
