## STANDARDS & SPECIFICATIONS SITE INSPECTION REPORT

LEVEL 1	(FIELD	REPORT)
---------	--------	---------

Project Name:	Mountain Valley Pipeline	S&S Program:	Mountain Valley Pipeline (SS027)
Inspector:	Marshall Willis	Inspection Date:	Friday, March 7, 2025
Project Contact:	Cory Chalmers Brian Clauto	Project Contact Email:	Cory.chalmers@eqt.com Brian.clauto@eqt.com
Spread H: Franklin County	STA 13140+00 - 13197+55 MVP-FR-292 MVP-FR-292.01	Site Conditions:	Wet

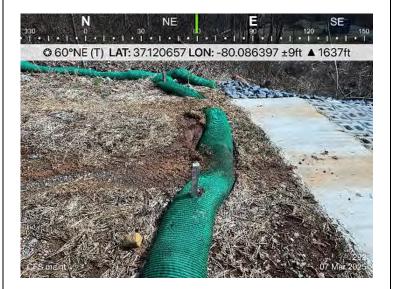
Fig. 1 MVP-FR-292: CFS maintenance required.

3.	Areas of o	ffsite	sediment deposition ob	serve	d?				$\boxtimes$	
	Routin -	ne Maintena MVP-FR-	a <b>nce:</b> 292: (	he following resources: ( <u>72-Hour Deadline</u> from CFS maintenance requ	n Noti ired.	ification)					
	Corre	ctive Actio	<u>on:</u> N	Aaintain and install a	ll con	trols per the approve	d S&	S.

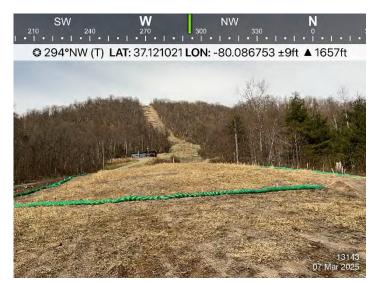
Fig. 2 **STA 13143+00:** Controls in place and functioning properly.

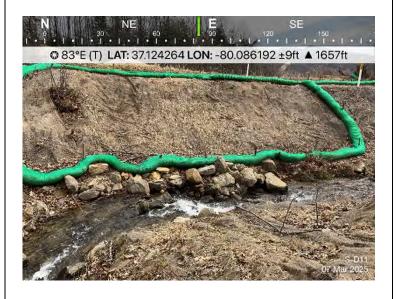
Fig. 3

Stream S-D11: Controls in place and functioning properly.

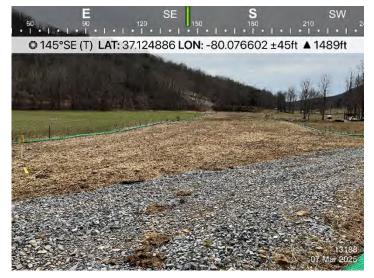
Fig. 4
STA 13188+00: Controls in place and functioning properly.
