STANDARDS & SPECIFICATIONS SITE INSPECTION REPORT

LEVEL 1 (FIELD REPORT)

Project Name:	Mountain Valley Pipeline	S&S Program:	Mountain Valley Pipeline (SS027)
Inspector:	Marshall Willis	Inspection Date:	Thursday, February 27, 2025
Project Contact:	Cory Chalmers Brian Clauto	Project Contact Email:	cchalmers@eqt.com bclauto@eqt.com
Spread I: Franklin County	STA 13784+35 - 13826+95 MVP-FR-300 MVP-FR-302	Site Conditions:	Dry

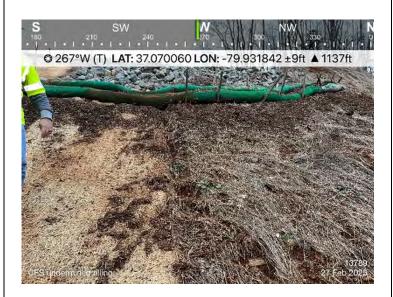
2.									\boxtimes				
	3.	Areas of of	ffsite	sediment deposition ob	serve	d?				\boxtimes				
	Routin	ne Maintena STA 1378	i nce: 39+00	he following resources: (72-Hour Deadline from: CFS undermined.	n Noti	ification)								
	Ineffec	ctive Contro N/A	ols: (<u>2</u>	<u>24-Hour Deadline</u> from	Notifi	cation)								
	Corre	ctive Actio	<u>on:</u> 1	N/A

Fig. 1 **STA 13789+00:** CFS undermined.

Deadline: Within 72-Hour of Notification

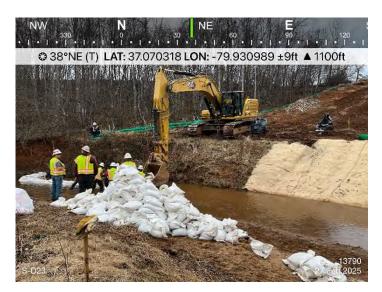
Fig. 2 **Stream S-D23:** Controls in place and functioning properly.

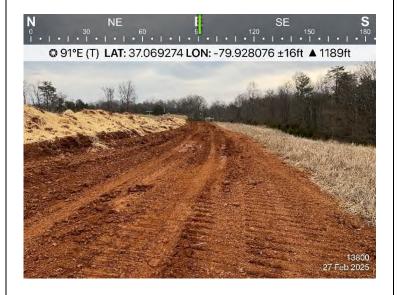
Fig. 3 **STA 13800+00:** Controls in place and functioning properly.

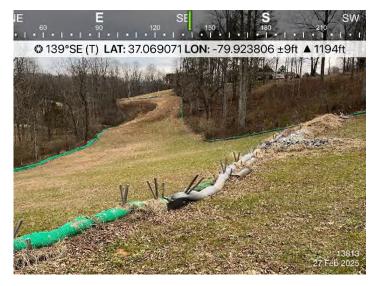
Fig. 4
STA 13813+00: Controls in place and functioning properly.
