STANDARDS & SPECIFICATIONS SITE INSPECTION REPORT

LEVEL 1 (FIELD REPORT)

Project Name:	Mountain Valley Pipeline	S&S Program:	Mountain Valley Pipeline (SS027)			
Inspector:	Marshall Willis	Inspection Date:	Friday, March 14, 2025			
Project Contact:	Cory Chalmers Brian Clauto	Project Contact Email:	Cory.chalmers@eqt.com Brian.clauto@eqt.com			
Spread I: Franklin County	STA 14345+53 - 14454+42 MVP-FR-313.01	Site Conditions:	Dry

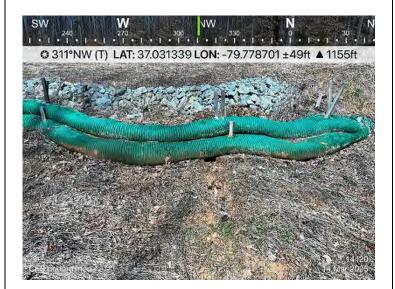
Fig. 1 **STA 14420+00:** CFS undermined.

3. Areas of offsite sediment deposition observed?								\boxtimes					
Comments: Inspected the following resources: S-A38, W-DD1, S-A41, S-GH37, S-GH39, S-GH40, S-GH44 and W-GH Routine Maintenance: (72-Hour Deadline from Notification) - STA 14420+00: Repair undermined CFS. Ineffective Controls: (24-Hour Deadline from Notification) - N/A Corrective Action: Maintain and install all controls per the approved S&S.											V-GH46.

Deadline: Within 72-Hour of Notification

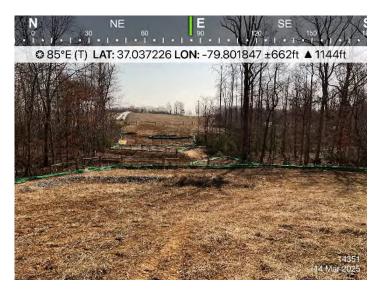
Fig. 2 **STA 14351+00:** Controls in place and functioning properly.

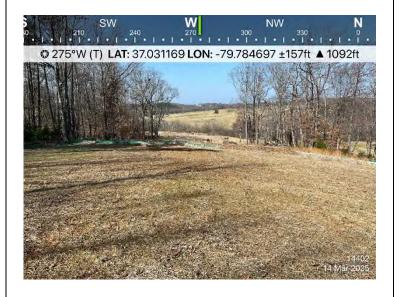
Fig. 3 **STA 14402+00:** Controls in place and functioning properly.

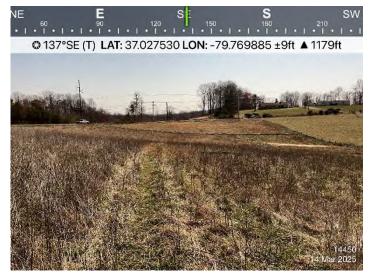
Fig. 4
STA 14450+00: Controls in place and functioning properly.
