# STANDARDS & SPECIFICATIONS SITE INSPECTION REPORT LEVEL 1 (FIELD REPORT)

| Project Name: | Mountain Valley Pipeline | S&S Program: | Mountain Valley Pipeline (SS027) |
| Inspector: | Marshall Willis | Inspection Date: | Thursday, March 13, 2025 |
| Spread H:<br>Roanoke County | STA 12776+00 – 12807+43<br>MVP-RO-282<br>MVP-RO-283 | Site Conditions: | Dry |

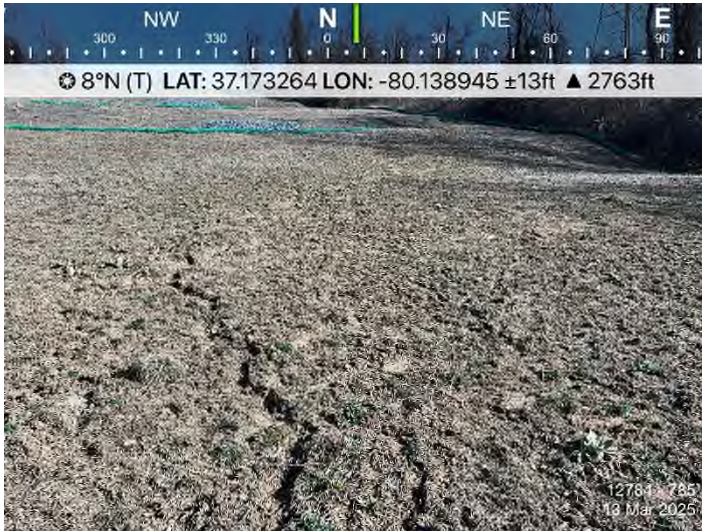
Fig. 1

**STA 12784+00 to 12785+00:** Repair and restabilize denuded areas.

- STA 12784+00 to 12785+00: Re-stabilize and repair denuded areas.

**Corrective Action:** Maintain and install all controls per the approved S&S.

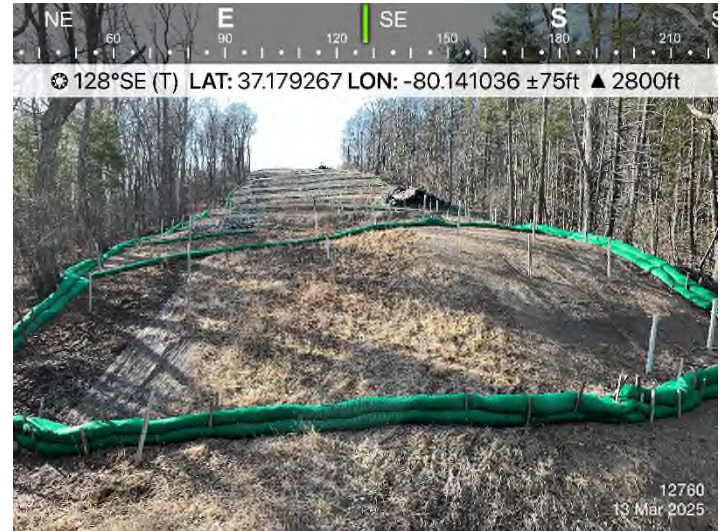
Fig. 2

**STA 12760+00:** Controls in place and functioning properly.

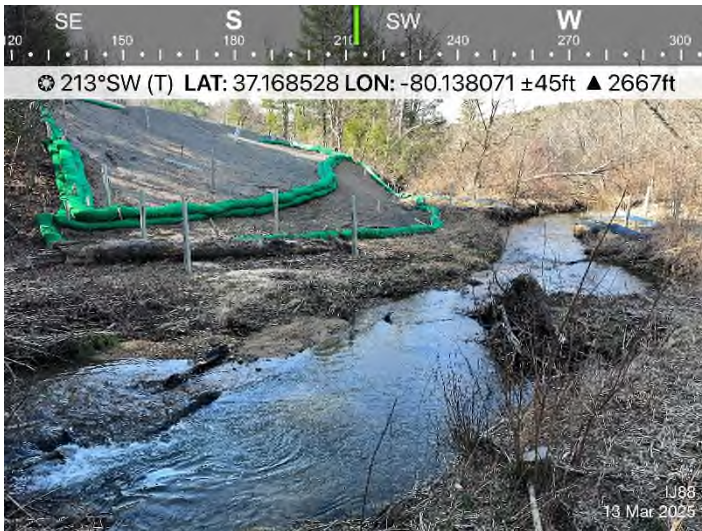
Fig. 3

**Stream S-IJ88:** Controls in place and functioning properly.

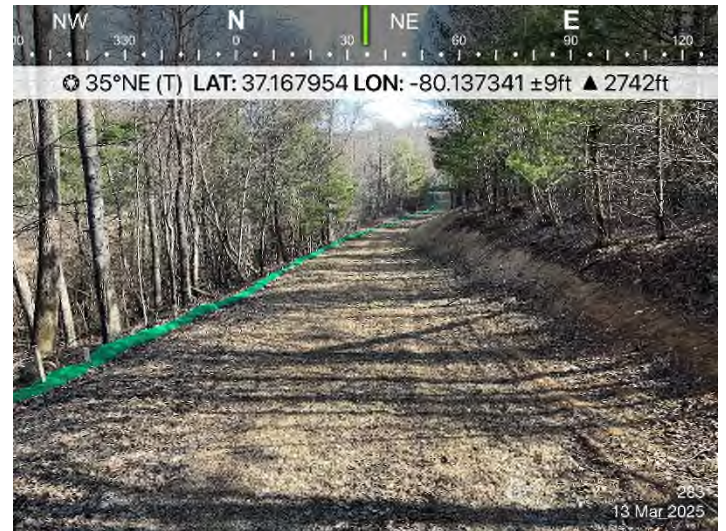
Fig. 4

**MVP-RO-283:** Controls in place and functioning properly.
