STANDARDS & SPECIFICATIONS SITE INSPECTION REPORT LEVEL 1 (FIELD REPORT)

Project Name:	Mountain Valley Pipeline	S&S Program:	Mountain Valley Pipeline (SS027)
Inspector: M. Willis	Matthew Grant	Inspection Date:	Wednesday, March 19, 2025
Project Contact:	Cory Chalmers Brian Clauto	Project Contact Email:	cchalmers@equitransmidstream.com bclauto@equitransmidstream.com
Spread I: Franklin County	STA 13790-13755+73, 14033-14010 ATWS 569A FR 300	Site Conditions:	Dry

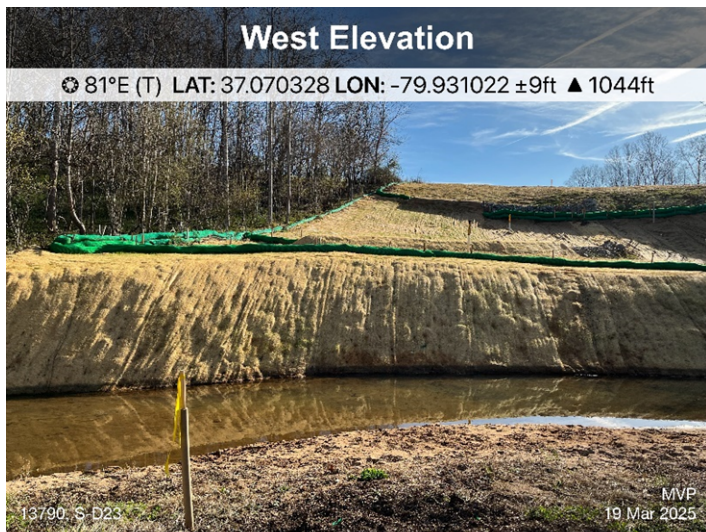
Fig. 1
Designated Crossing S-D23 bank has been repaired, and ESC remains in place.

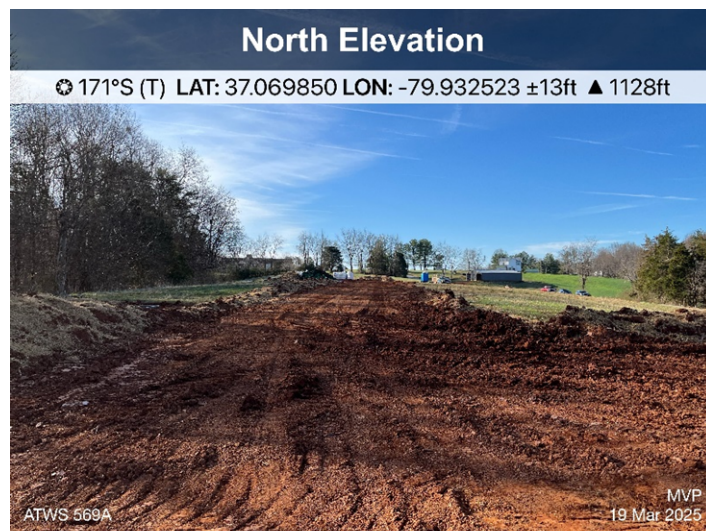
Fig. 2
ATWS 569A, ESC measures are in place.

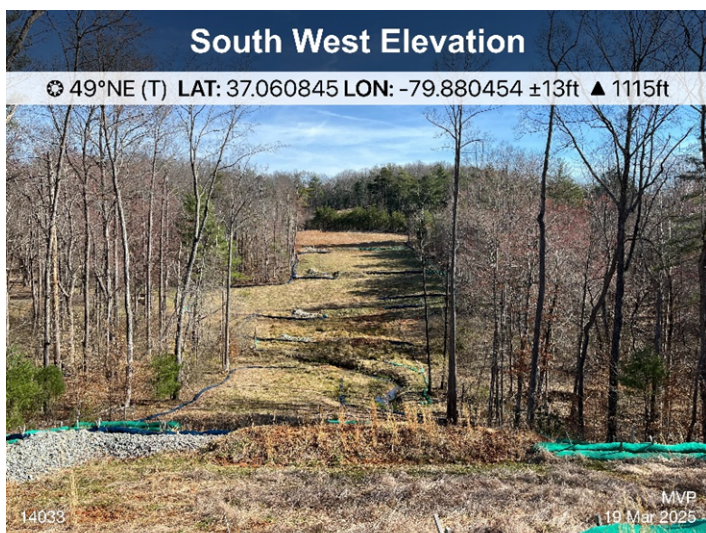
Fig. 3
STA 14033, ESC is remains in place.

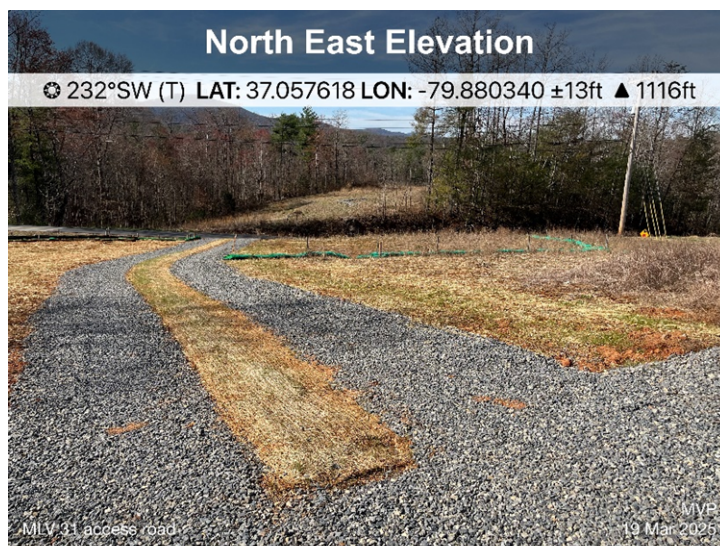
Fig. 4
MLV 31 access road bmp has been installed.
