Project Name:	Mountain Valley Pipeline	Inspector: M. Willis	Matthew Grant
Inspection Date:	Tuesday, March 18, 2025	Project Contact:	Brian Clauto
Spread H: Montgomery	Sta 12453-12501+60 MN 279.01, 268 MLV 28 ATWS 473. 645A	Weather:	Dry

FIELD INSPECTION PHOTO LOG

Project Name: Mountain Valley Pipeline <u>Date</u>: Tuesday, March 18, 2025

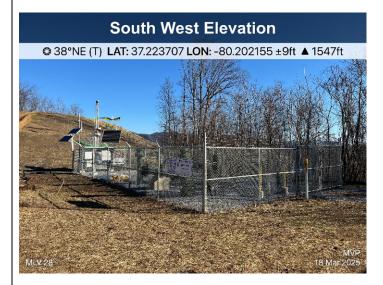
Figure 1: MLV 28, ESC remains in place.

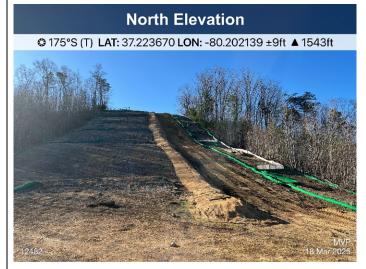
Figure 2: STA 12482, ESC's remains in place.

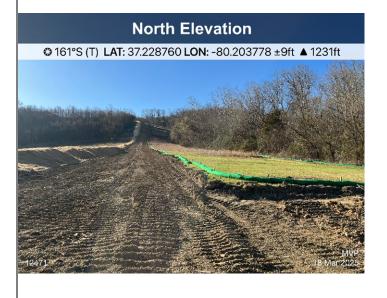
Figure 3: STA 12471, ESC is in place.

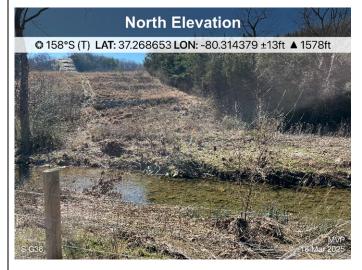
<u>Figure 4</u>: Designated crossing S-G38, permanent waterbars are in place near crossing.
