Project Name:	Mountain Valley Pipeline	Inspector: M. Willis	Matthew Grant
Inspection Date:	Monday, March 17, 2025	Project Contact:	Brian Clauto Cory Chalmers
Spread G: Giles	Sta 10820-10860 GI 241.03	Weather:	Dry

FIELD INSPECTION PHOTO LOG

Project Name: Mountain Valley Pipeline <u>Date</u>: Monday, March 17, 2025

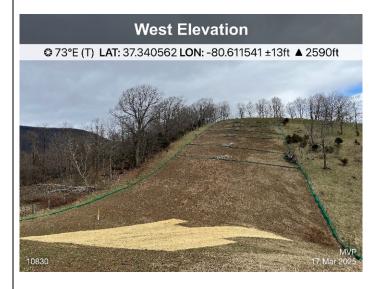
Figure 2: STA 10830, re stabilization is required on denuded areas.

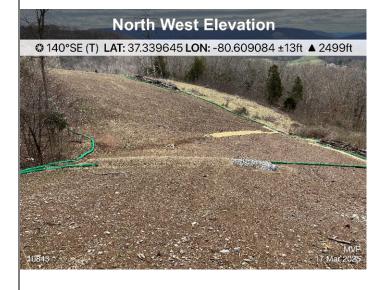
Figure 3: STA 10843, re stabilization is required on denuded areas.

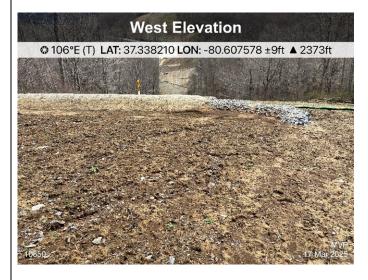
<u>Figure 4</u>: STA 10850, permanent waterbar requires cleanout and re stabilization.
