STANDARDS & SPECIFICATIONS SITE INSPECTION REPORT

LEVEL 1 (FIELD REPORT)

| Project Name: | Mountain Valley Pipeline | S&S Program: | Mountain Valley Pipeline (SS027) |
| Spread H: Montgomery County | STA 12416+00 - 12483+00 MVP-MN279/279.01 MVP-MLV-AR-28 | Site Conditions: | Dry |

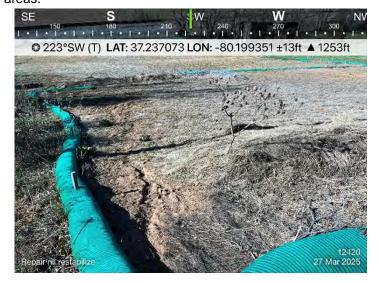
Fig. 1

STA 12420+00 to 12421+00: Repair and restabilize denuded areas.

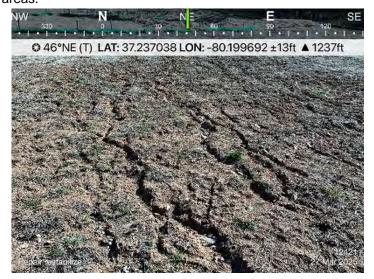
Fig. 2

STA 12420+00 to 12421+00: Repair and restabilize denuded areas.

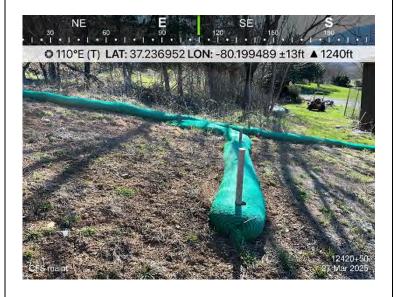
Fig. 3

STA 12420+50: CFS maintenance needed.

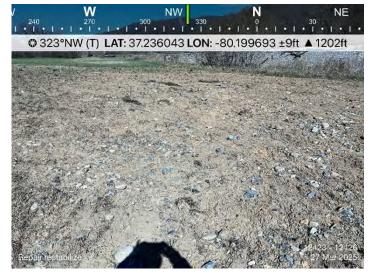
Fig. 4

STA 12423+00 to 12426+00: Repair and restabilize denuded areas.
