STANDARDS & SPECIFICATIONS COMPLAINT INVESTIGATION REPORT

Project Name:	Mountain Valley Pipeline (MVP)	S&S Program:	Mountain Valley Pipeline (SS027)			
Inspector:	Marshall Willis	Inspection Date:	Friday, March 28, 2025			
Project Contact:	Brian Clauto (EQT) Cory Chalmers (EQT)	Project Contact Email:	Cory.chalmers@eqt.com Brian.clauto@eqt.com			
Spread G: Montgomery County	STA 11668+00 - 11788+43	Site Conditions:	Dry

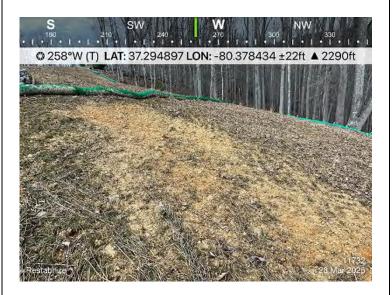
Fig. 1 STA 11732+00: Restabilize denuded area.

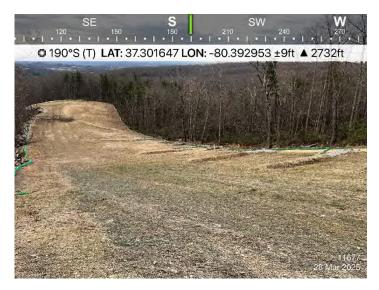
Fig. 2
STA 11677+00: Controls installed and functioning properly.

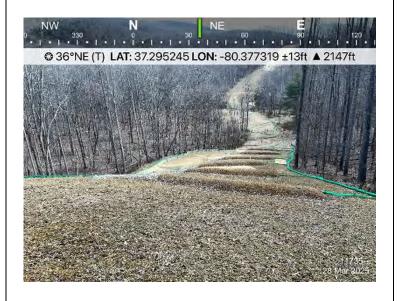
Fig. 3 STA 11735+00: Controls installed and functioning properly.

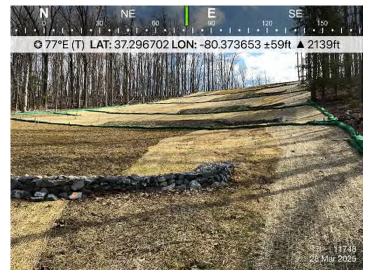
Fig. 4
STA 11748+00: Controls installed and functioning properly.
