## STANDARDS & SPECIFICATIONS SITE INSPECTION REPORT

**LEVEL 1 (FIELD REPORT)**

Project Name:	Mountain Valley Pipeline	S&S Program:	Mountain Valley Pipeline (SS027)
Inspector:	Marshall Willis	Inspection Date:	Thursday, April 17, 2025
Project Contact:	Cory Chalmers Brian Clauto	Project Contact Email:	cory.chalmers@eqt.com brian.clauto@eqt.com
Spread G: Giles County	STA 11326+85 - 11355+00 MVP-GI-256/256.02	Site Conditions:	Dry

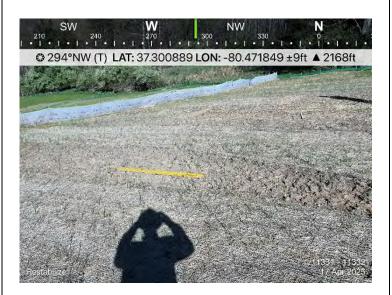
Fig. 1 **STA 11331+00 to 11332+00:** Restabilize denuded areas.

3.	Areas of of	ffsite	sediment deposition ol	serve	d?				$\boxtimes$					
	Comments: Inspected the following resources: S-NN11 and S-NN12.  Routine Maintenance: (72-Hour Deadline from Notification) - STA 11331+00 to 11332+00: Restabilize denuded areas STA 11352+00: Restabilize denuded areas.  Ineffective Controls: (24-Hour Deadline from Notification) - N/A  Corrective Action: Maintain and install all controls per the approved S&S.

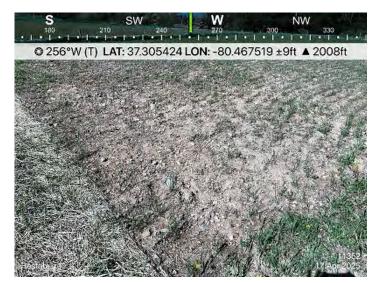
Fig. 2 **STA 11352+00:** Restabilize denuded areas.

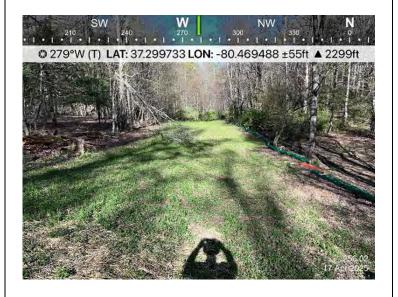
Fig. 3 **MVP-GI-256.02:** Controls in place and functioning properly.

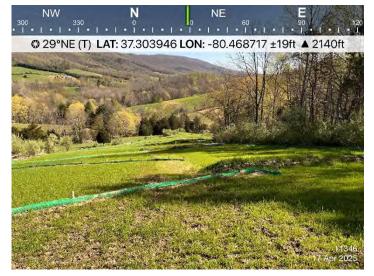
Fig. 4 STA 11346+00: Controls in place and functioning properly.
