STANDARDS & SPECIFICATIONS SITE INSPECTION REPORT

LEVEL 1 (FIELD REPORT)

Project Name:	Mountain Valley Pipeline	S&S Program:	Mountain Valley Pipeline (SS027)
Inspector:	Marshall Willis	Inspection Date:	Friday, April 25, 2025
Project Contact:	Cory Chalmers Brian Clauto	Project Contact Email:	cory.chalmers@eqt.com brian.clauto@eqt.com
Spread I: Pittslyvania County	STA 15296+00 - 15370+62 MVP-PI-332	Site Conditions:	Dry

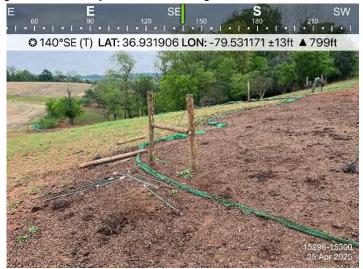
Fig. 1

STA 15296+00 to STA 15300+00: Landowner has resumed agricultural activity. Remove damaged controls.

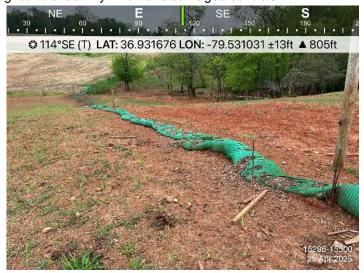
Fig. 2

STA 15296+00 to STA 15300+00: Landowner has resumed agricultural activity. Remove damaged controls.

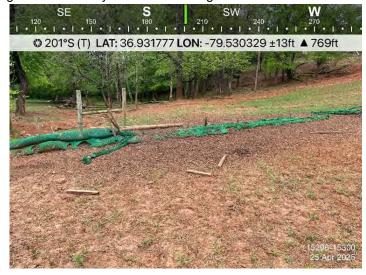
Fig. 3

STA 15296+00 to STA 15300+00: Landowner has resumed agricultural activity. Remove damaged controls.

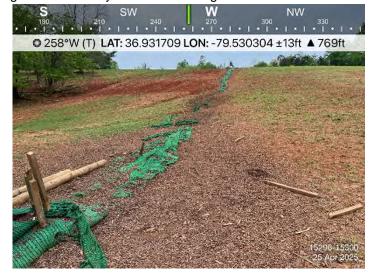
Fig. 4

STA 15296+00 to STA 15300+00: Landowner has resumed agricultural activity. Remove damaged controls.

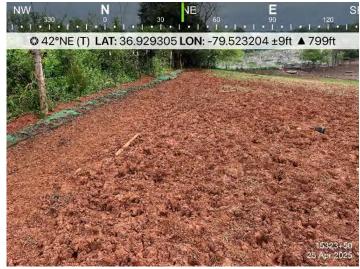
Fig. 5

STA 15323+50 to STA 15333+19: Landowner has resumed agricultural activity. Remove damaged controls.

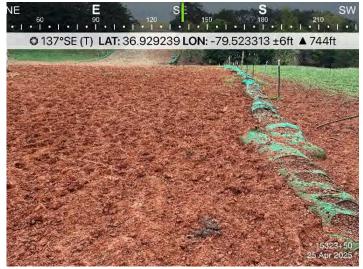
Fig. 6

STA 15323+50 to STA 15333+19: Landowner has resumed agricultural activity. Remove damaged controls.

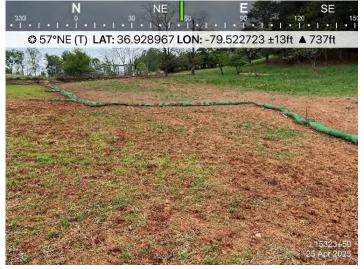
Fig. 7

STA 15323+50 to STA 15333+19: Landowner has resumed agricultural activity. Remove damaged controls.

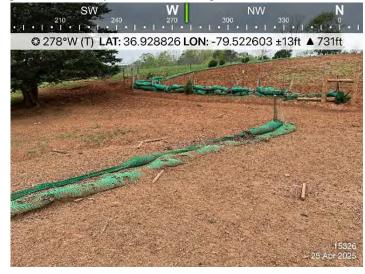
Fig. 8

STA 15323+50 to STA 15333+19: Landowner has resumed agricultural activity. Remove damaged controls.
