STANDARDS & SPECIFICATIONS SITE INSPECTION REPORT

LEVEL 1 (FIELD REPORT)

Project Name:	Mountain Valley Pipeline	S&S Program:	Mountain Valley Pipeline (SS027)
Inspector:	Marshall Willis	Inspection Date:	Tuesday, May 13, 2025
Project Contact:	Cory Chalmers Brian Clauto	Project Contact Email:	cory.chalmers@eqt.com brian.clauto@eqt.com
Spread I: Franklin County	STA 13958+31 - 14000+00 MVP-FR-306.02	Site Conditions:	Rainy

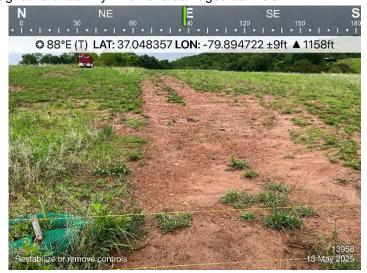
Fig. 1

STA 13958+00 to STA 13980+00: Landowner has resumed agricultural activity. Remove damaged controls.

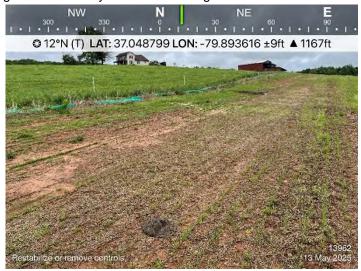
Fig. 2

STA 13958+00 to STA 13980+00: Landowner has resumed agricultural activity. Remove damaged controls.

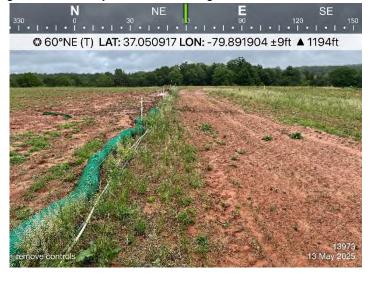
Fig. 3

STA 13958+00 to STA 13980+00: Landowner has resumed agricultural activity. Remove damaged controls.

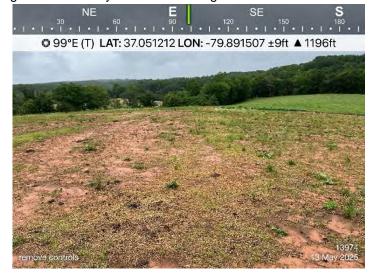
Fig. 4

STA 13958+00 to STA 13980+00: Landowner has resumed agricultural activity. Remove damaged controls.
