# STANDARDS & SPECIFICATIONS SITE INSPECTION REPORT LEVEL 1 (FIELD REPORT)

| Project Name: | Mountain Valley Pipeline | S&S Program: | Mountain Valley Pipeline (SS027) |
| Inspector: | Marshall Willis | Inspection Date: | Friday, May 16, 2025 |
| Spread H:<br>Roanoke County | STA 12957+38 – 12973+43<br>MVP-RO-288 | Site Conditions: | Dry |

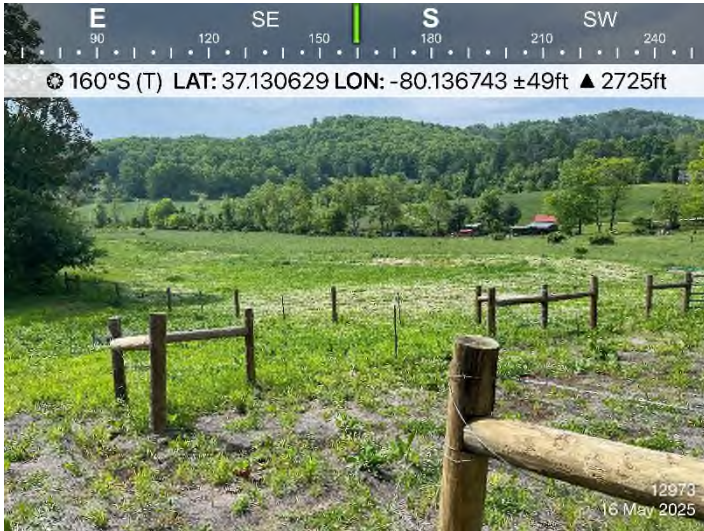
Fig. 1

**STA 12973+00:** Controls in place and functioning properly.

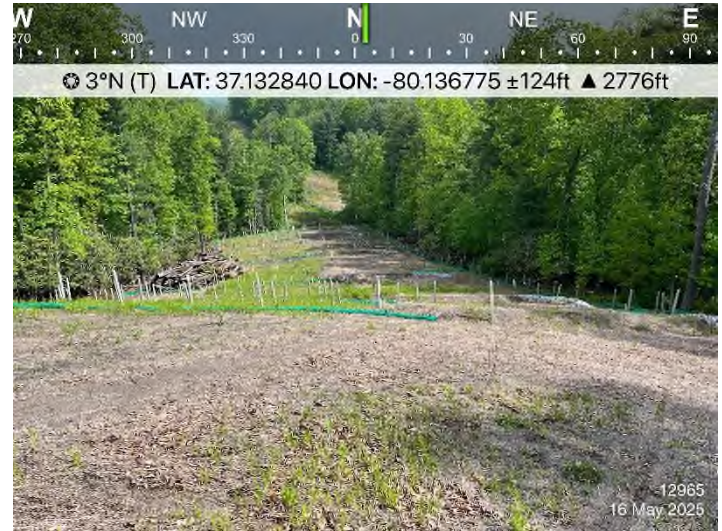
Fig. 2

**STA 12965+00:** Controls in place and functioning properly.

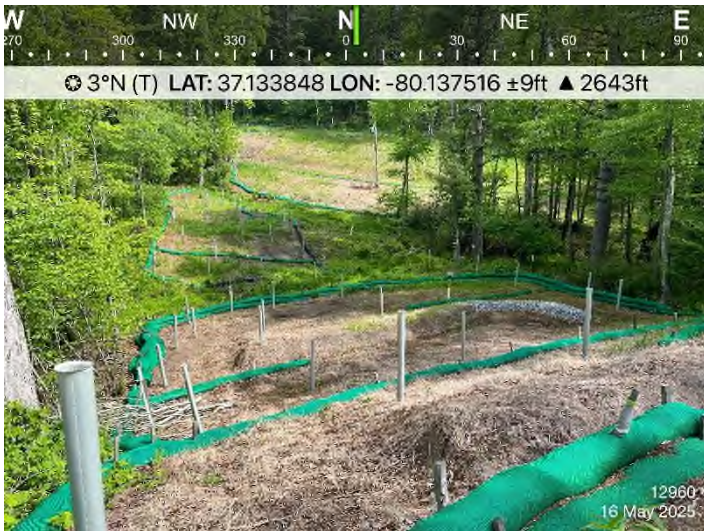
Fig. 3

**STA 12960+00:** Controls in place and functioning properly.

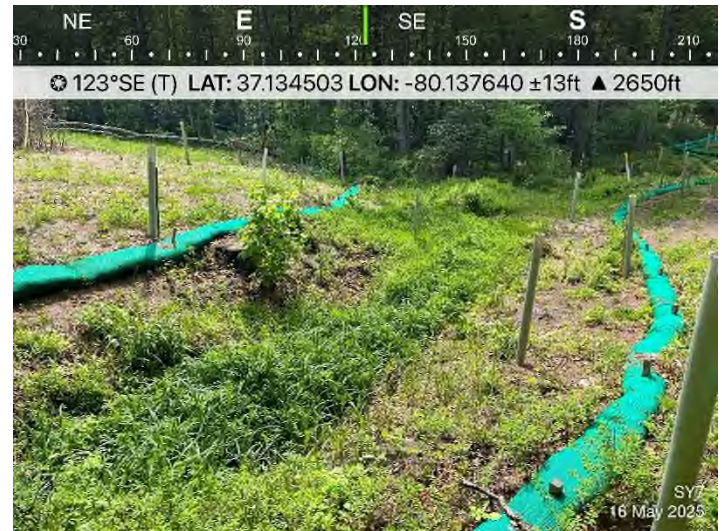
Fig. 4

**Stream S-Y7:** Controls in place and functioning properly.
