STANDARDS & SPECIFICATIONS SITE INSPECTION REPORT LEVEL 1 (FIELD REPORT)

Project Name:	Mountain Valley Pipeline	S&S Program:	Mountain Valley Pipeline (SS027)
Inspector:	Marshall Willis	Inspection Date:	Thursday, May 15, 2025
Project Contact:	Cory Chalmers Brian Clauto	Project Contact Email:	cory.chalmers@eqt.com brian.clauto@eqt.com
Spread H: Montgomery County	STA 12186+00 – 12284+75 MVP-MN-274 MVP-MN-275 MVP-MN-276.03	Site Conditions:	Dry

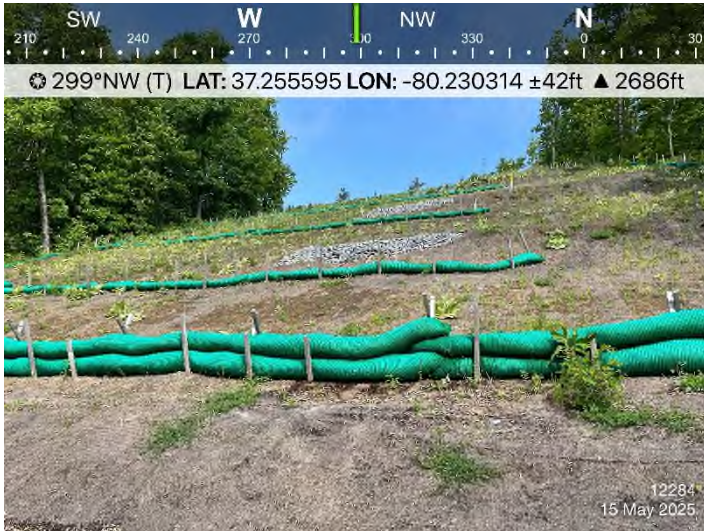
Fig. 1

STA 12284+00: Controls in place and functioning properly.

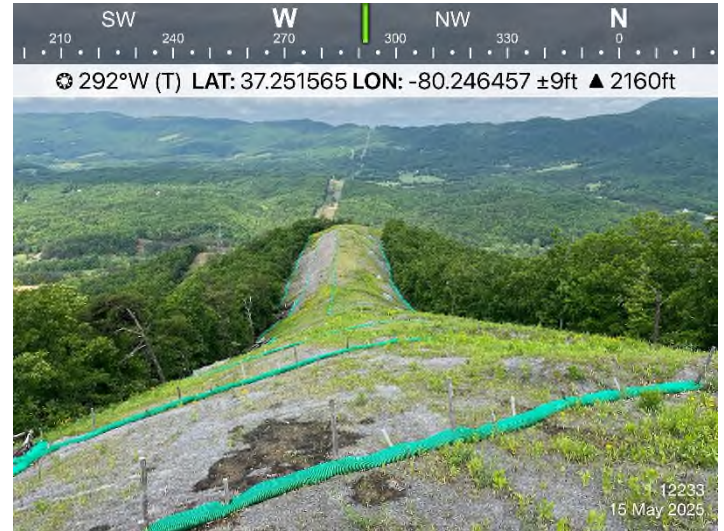
Fig. 2

STA 12233+00: Controls in place and functioning properly.

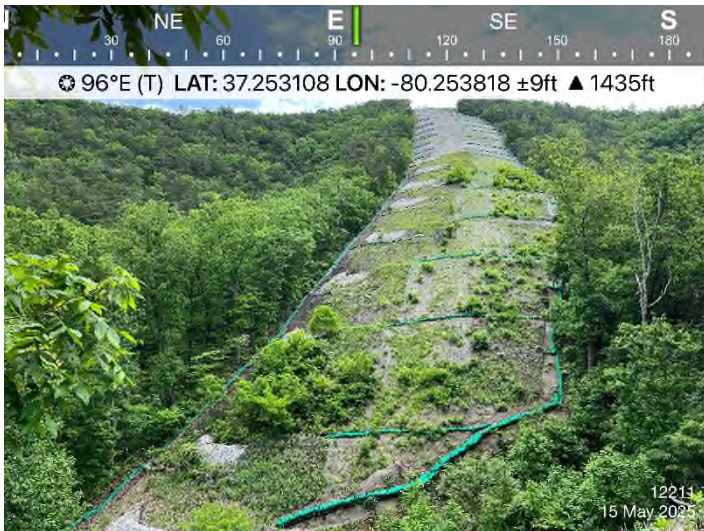
Fig. 3

STA 12211+00: Controls in place and functioning properly.

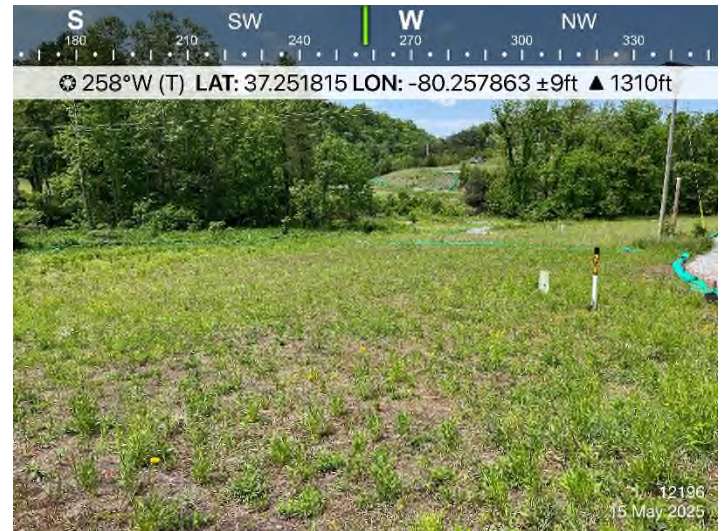
Fig. 4

STA 12196+00: Controls in place and functioning properly.
