STANDARDS & SPECIFICATIONS SITE INSPECTION REPORT

LEVEL 1 (FIELD REPORT)

Project Name:	Mountain Valley Pipeline	S&S Program:	Mountain Valley Pipeline (SS027)			
Inspector:	Marshall Willis	Inspection Date:	Tuesday, May 27, 2025			
Project Contact:	Cory Chalmers Brian Clauto	Project Contact Email:	cory.chalmers@eqt.com brian.clauto@eqt.com			
Spread H: Montgomery County Roanoke County	MVP-MLV-AR-28 MVP-RO-279.01 MVP-RO-281	Site Conditions:	Rainy

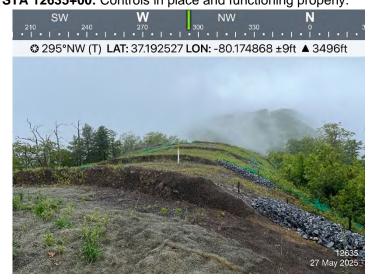
Fig. 1 **STA 12635+00:** Controls in place and functioning properly.

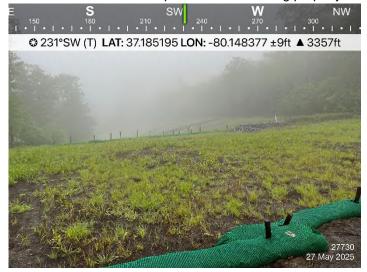
Fig. 2

STA 12730+00: Controls in place and functioning properly.

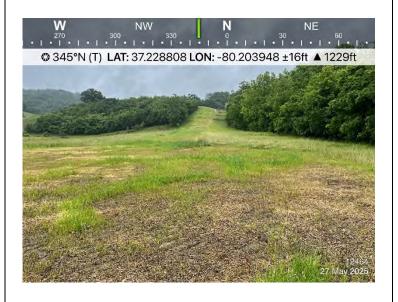
Fig. 3 **STA 12464+00:** Controls in place and functioning properly.

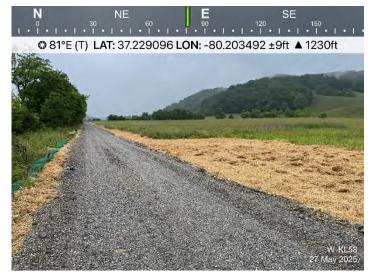
Fig. 4

MVP-MLV-AR-28: Controls in place and functioning properly.
