STANDARDS & SPECIFICATIONS SITE INSPECTION REPORT

LEVEL 1 (FIELD REPORT)

Project Name:	Mountain Valley Pipeline	S&S Program:	Mountain Valley Pipeline (SS027)
Inspector:	Marshall Willis	Inspection Date:	Thursday, May 22, 2025
Project Contact:	Cory Chalmers Brian Clauto	Project Contact Email:	cory.chalmers@eqt.com brian.clauto@eqt.com
Spread I: Franklin County	STA 14758+16 - 14845+68	Site Conditions:	Dry

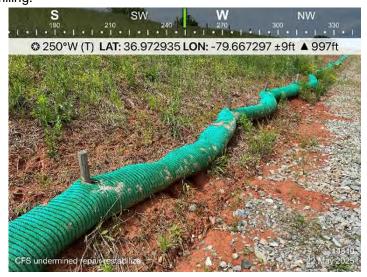
Fig. 1

3. Areas of offsite sediment deposition observed?							\boxtimes					
 Comments: Inspected the following resources: S-MM44, S-MM45, S-MM48, S-H25, W-H9, S-H24, S-H23, S-A14, S-H and S-A13. Routine Maintenance: STA 14840+00: CFS undermined. Repair and restabilize. Ineffective Controls: N/A Corrective Action: Maintain and install all controls per the approved S&S. 										O-1 II 11			
The cons	titute non-compliaring compliance of	rective action on the above pro	deadline date applies to a rective actions are not copject.		ions noted on this report ι l by the deadline, other en

STA 14840+00: CFS undermined. Restabilize and repair rilling.

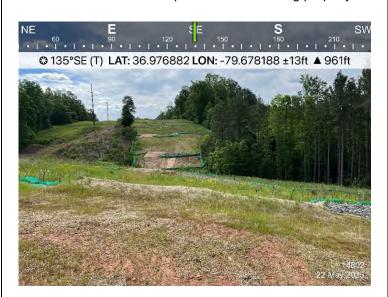
Fig. 2 **STA 14802+00:** Controls in place and functioning properly.

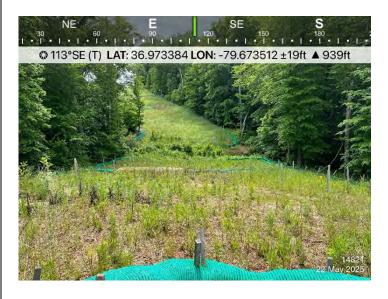
Fig. 3 STA 14821+00: Controls in place and functioning properly.

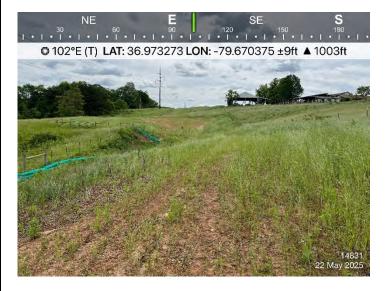
Fig. 4 STA 14831+00: Controls in place and functioning properly.
