STANDARDS & SPECIFICATIONS SITE INSPECTION REPORT LEVEL 1 (FIELD REPORT)

Project Name:	Mountain Valley Pipeline	S&S Program:	Mountain Valley Pipeline (SS027)
Inspector:	Marshall Willis	Inspection Date:	Friday, June 6, 2025
Project Contact:	Cory Chalmers Brian Clauto	Project Contact Email:	cory.chalmers@eqt.com brian.clauto@eqt.com
Spread H: Montgomery County	Pipeyard 006 Laydown Yard 049	Site Conditions:	Dry

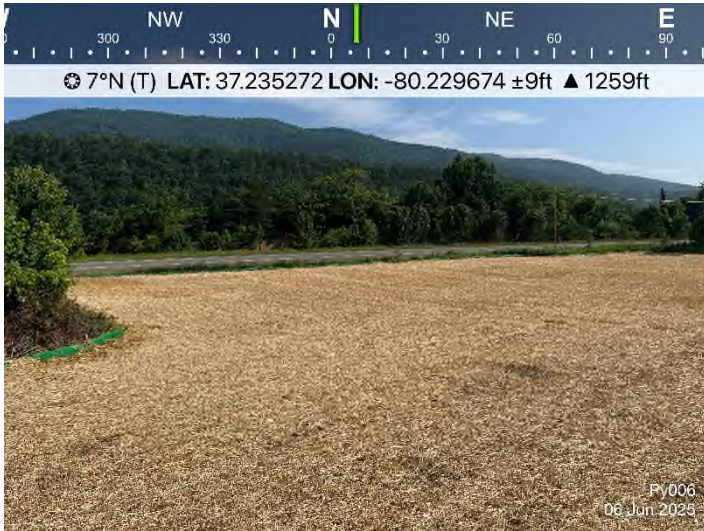
Fig. 1
Pipeyard 006: Controls in place and functioning properly.

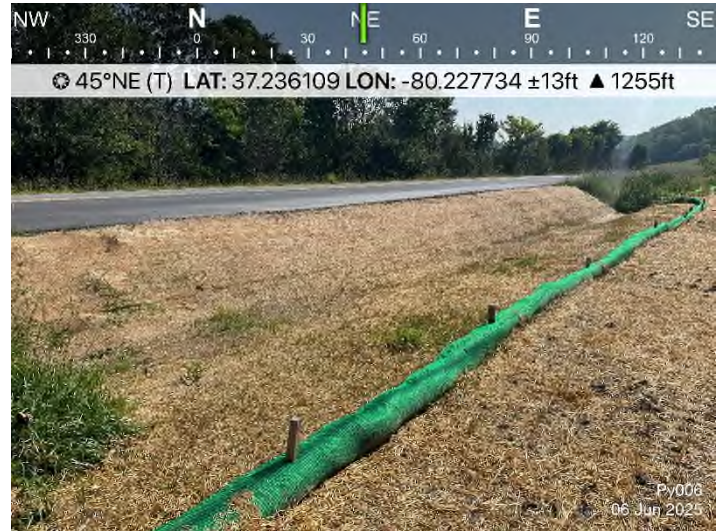
Fig. 2
Pipeyard 006: Controls in place and functioning properly.

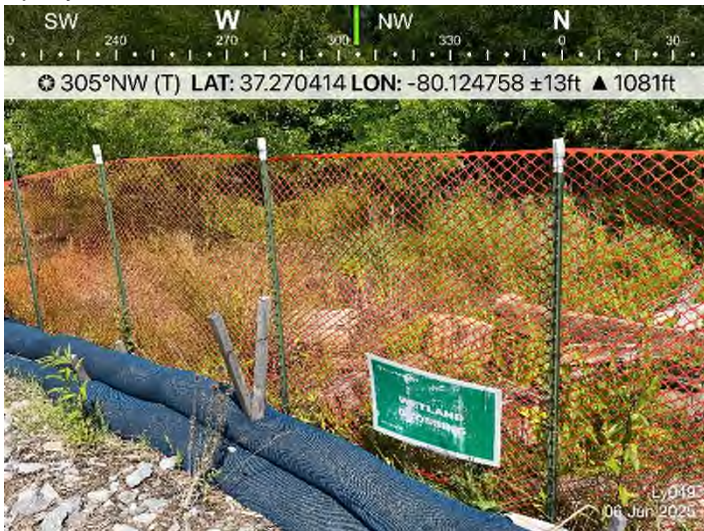
Fig. 3
Laydown Yard 049: Controls in place and functioning properly.

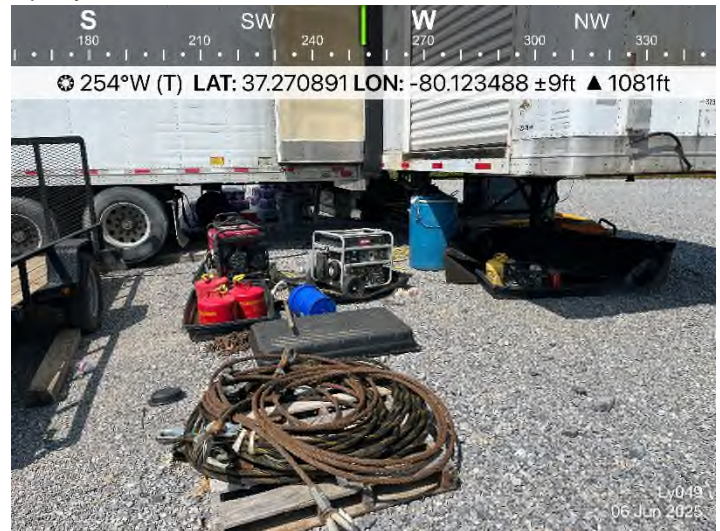
Fig. 4
Laydown Yard 049: Controls in place and functioning properly.
