Mountain Valley Pipeline

STANDARDS & SPECIFICATIONS SITE INSPECTION REPORT

LEVEL 1 (FIELD REPORT)

Mountain Valley Pipeline (SS027)

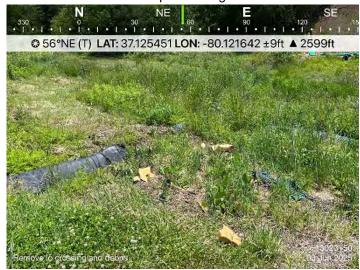
Fig. 1 STA 13023+50: Remove/repair damaged controls.

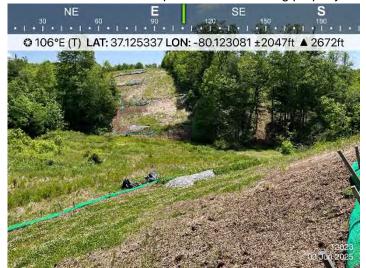
Fig. 2

STA 13023+00: Controls in place and functioning properly.

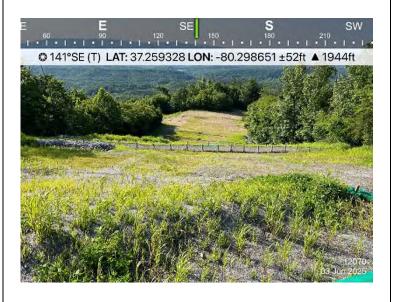
Fig. 3 **STA 12070+00:** Controls in place and functioning properly.

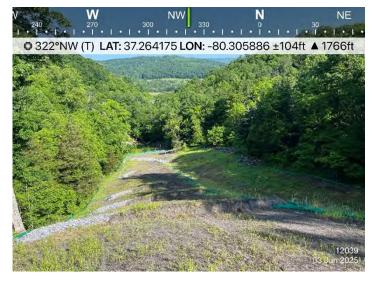
Fig. 4

STA 12039+00: Controls in place and functioning properly.
