## STANDARDS & SPECIFICATIONS SITE INSPECTION REPORT

**LEVEL 1 (FIELD REPORT)**

Project Name:	Mountain Valley Pipeline	S&S Program:	Mountain Valley Pipeline (SS027)
Inspector:	Marshall Willis	Inspection Date:	Thursday, June 5, 2025
Project Contact:	Cory Chalmers Brian Clauto	Project Contact Email:	cory.chalmers@eqt.com brian.clauto@eqt.com
Spread I: Franklin County	STA 13690+91 - 13784+35 MVP-FR-300	Site Conditions:	Dry

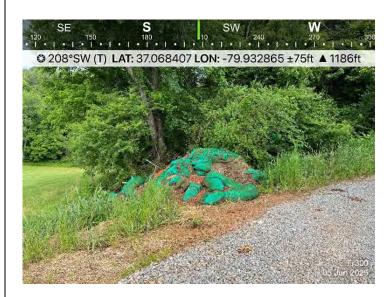
Fig. 1 MVP-FR-300: Remove damaged controls off LOD.

3.	3. Areas of offsite sediment deposition observed?								$\boxtimes$				
Routine Maintenance (72-Hr):  - MVP-FR-300: Remove damaged controls piled of ROW by landowner.  Ineffective Controls (24-Hr):  - N/A  Corrective Action: Maintain and install all controls per the approved S&S.														
The reconst	ecommended itute non-compling compliance	corrective ac pliance and/c e on the abo	ction de or corre ve pro	ective actions are not con ject.		ions noted on this report υ l by the deadline, other en

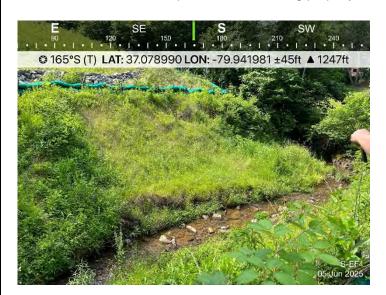
Fig. 2 **Stream S-EF54:** Controls in place and functioning properly.

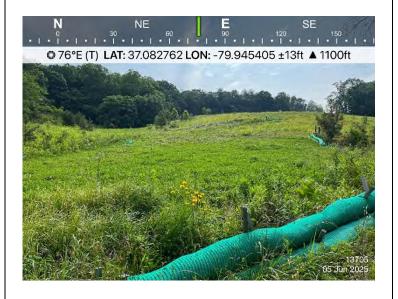
Fig. 3 **STA 13705+00:** Controls in place and functioning properly.

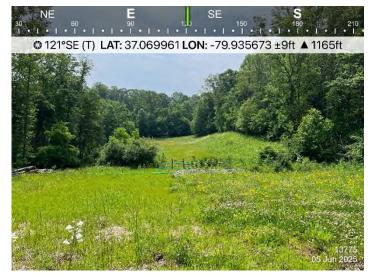
Fig. 4
STA 13775+00: Controls in place and functioning properly.
