### **STANDARDS & SPECIFICATIONS** SITE INSPECTION REPORT

**LEVEL 1 (FIELD REPORT)**

Project Name:	Mountain Valley Pipeline	S&S Program:	Mountain Valley Pipeline (SS027)
Inspector:	Marshall Willis	Inspection Date:	Wednesday, June 4, 2025
Project Contact:	Cory Chalmers Brian Clauto	Project Contact Email:	cory.chalmers@eqt.com brian.clauto@eqt.com
Spread I: Franklin County	STA 14222+00 - 14249+19 MVP-MLV-AR-32 MVP-FR-311	Site Conditions:	Dry

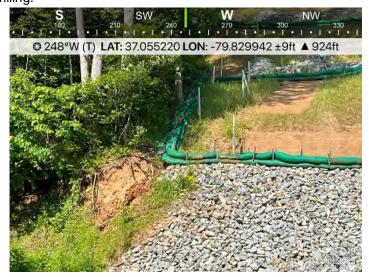
Fig. 1 STA 14232+50: CFS undermined. Restabilize and repair rilling.

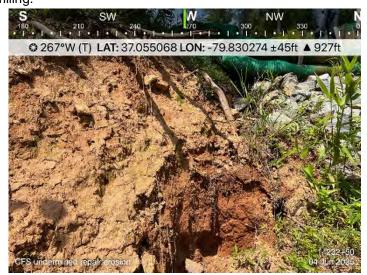
Fig. 2 **STA 14232+50:** CFS undermined. Restabilize and repair rilling.

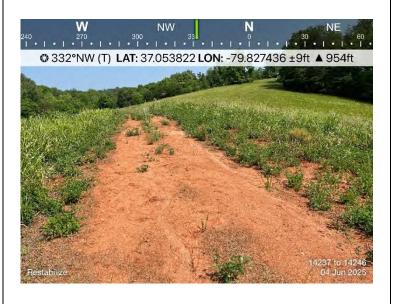
Fig. 3 **STA 14237+00 to 14246+00:** Restabilize denuded areas.

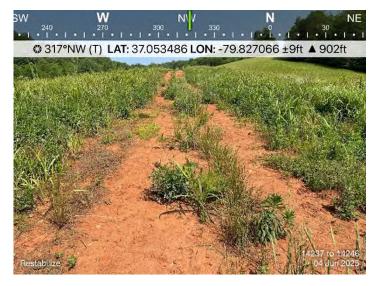
Fig. 4 **STA 14237+00 to 14246+00:** Restabilize denuded areas.
