STANDARDS & SPECIFICATIONS SITE INSPECTION REPORT

LEVEL 1 (FIELD REPORT)

Project Name:	Mountain Valley Pipeline	S&S Program:	Mountain Valley Pipeline (SS027)
Inspector:	Matthew Grant	Inspection Date:	Monday, June 2, 2025
Project Contact:	Cory Chalmers Brian Clauto	Project Contact Email:	Cory.chalmers@eqt.com Brian.clauto@eqt.com
Spread G: Giles County	STA 11060+75-10930 MLV 25	Site Conditions:	Dry

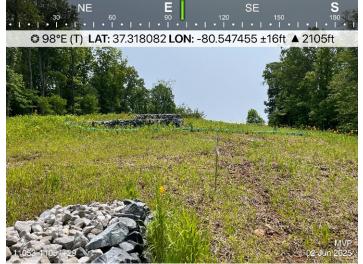
Fig. 2 STA 11053-11051+29: Repair and restabilize denuded areas.

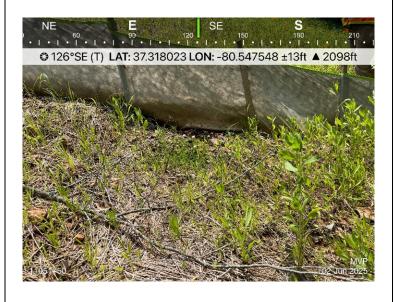
Fig. 3 STA 11051+50: P1 maintenance needed.

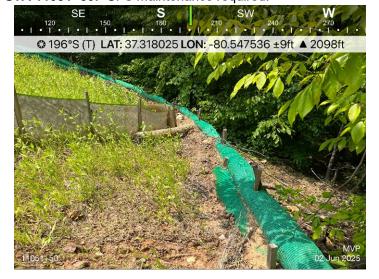
Fig. 4 STA 11051+50: CFS maintenance required.
