# STANDARDS & SPECIFICATIONS SITE INSPECTION REPORT LEVEL 1 (FIELD REPORT)

| Project Name: | Mountain Valley Pipeline | S&S Program: | Mountain Valley Pipeline (SS027) |
| Spread H:<br>Franklin County | MVP-MLV-AR-29<br>STA 13316+13 – 13342+67 | Site Conditions: | Dry |

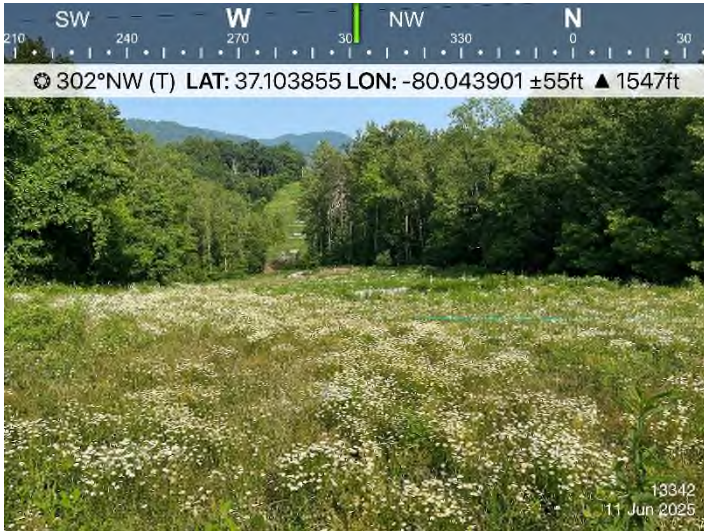
Fig. 1

**STA 13342+00:** Controls in place and functioning properly.

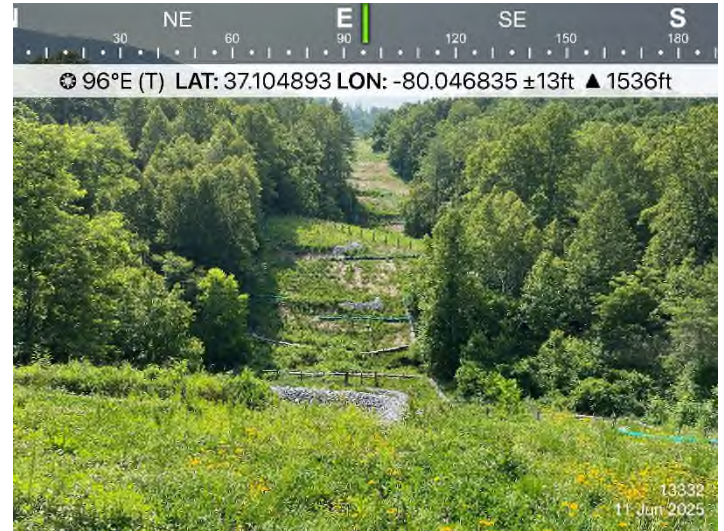
Fig. 2

**STA 13332+00:** Controls in place and functioning properly.

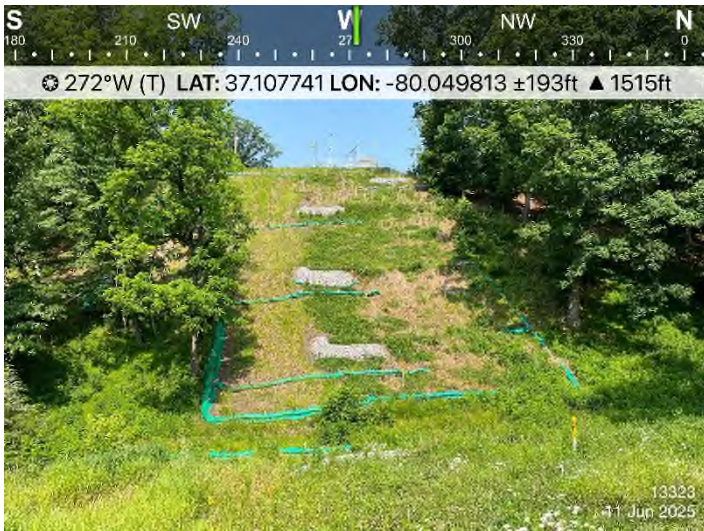
Fig. 3

**STA 13323+00:** Controls in place and functioning properly.

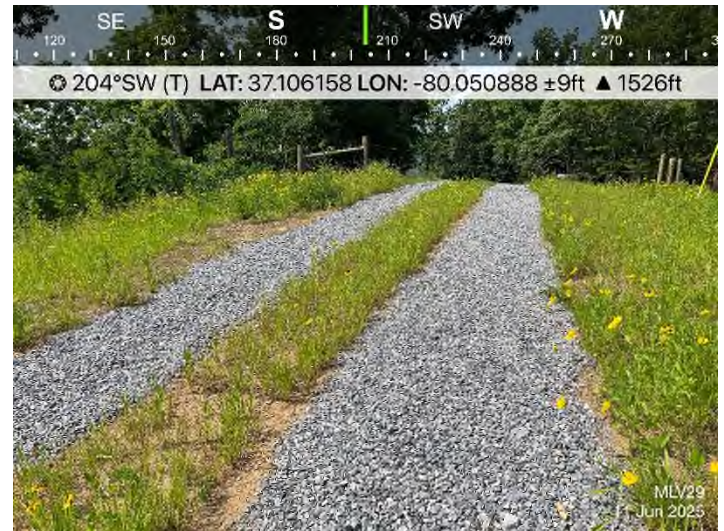
Fig. 4

**MVP-MLV-AR-29** Controls in place and functioning properly.
