# STANDARDS & SPECIFICATIONS SITE INSPECTION REPORT LEVEL 1 (FIELD REPORT)

| Project Name: | Mountain Valley Pipeline | S&S Program: | Mountain Valley Pipeline (SS027) |
| Spread G:<br>Montgomery County | STA 11696+94 – 11618+91<br>MVP-MN-258.05 | Site Conditions: | Dry |

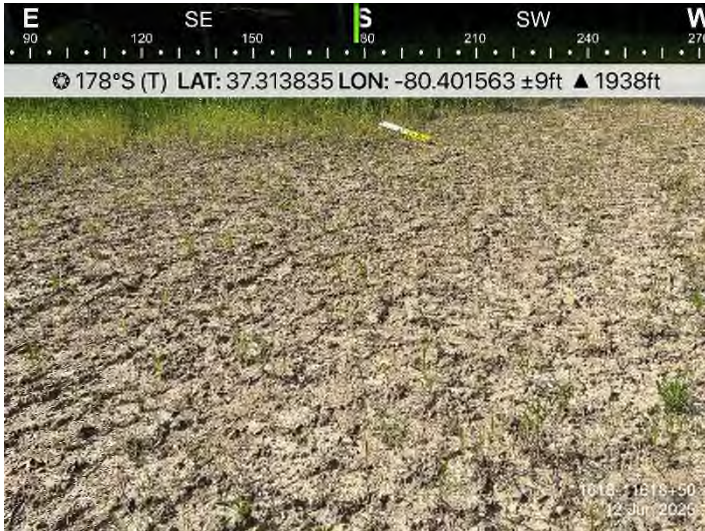
Fig. 1

**STA 11618+00 to 11618+50:** Restabilize denuded areas.

- STA 11618+00 to 11618+50: Restabilize area.

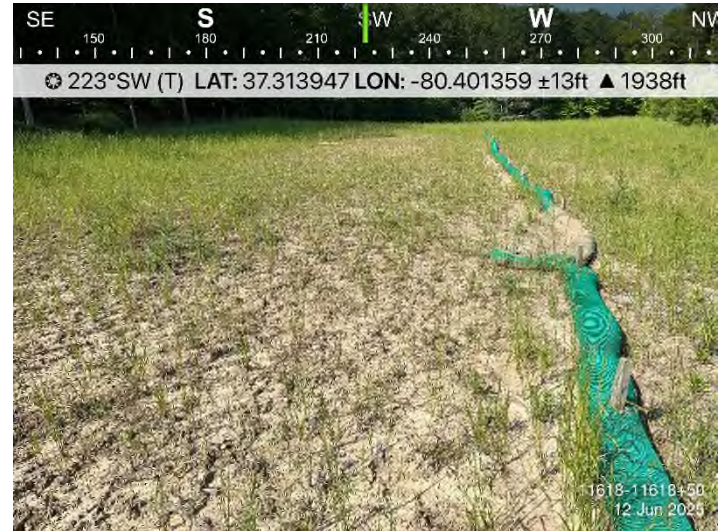
Fig. 2

**STA 11618+00 to 11618+50:** Restabilize denuded areas.

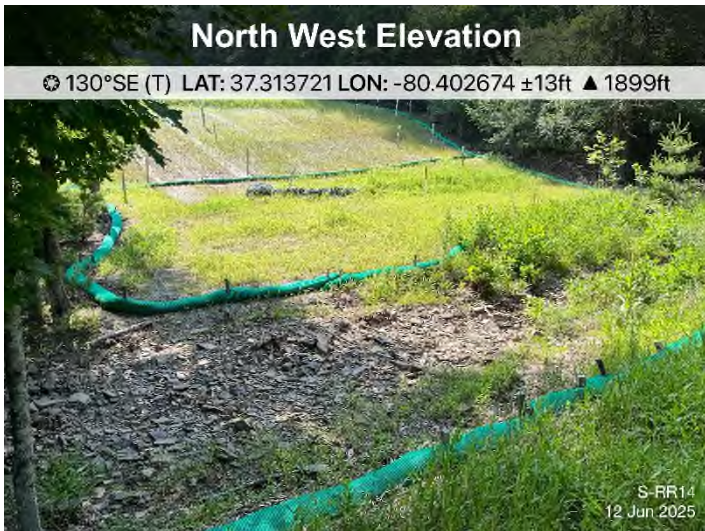
Fig. 3

**Stream S-RR14:** Controls in place and functioning properly.

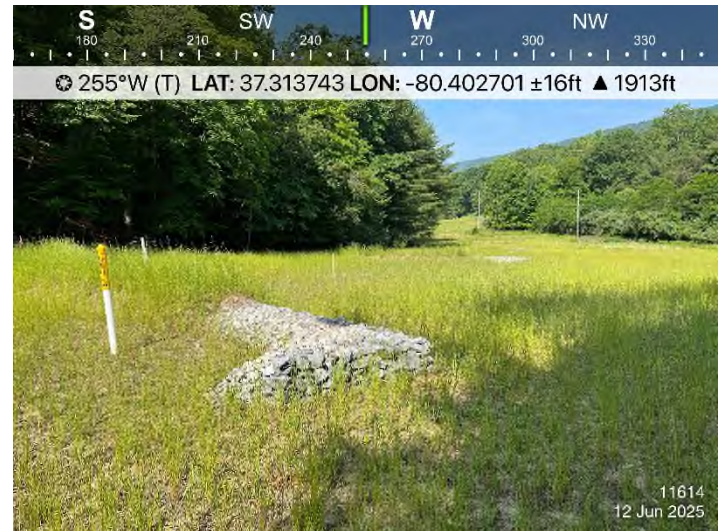
Fig. 4

**STA 11614+00:** Controls in place and functioning properly.
