STANDARDS & SPECIFICATIONS SITE INSPECTION REPORT LEVEL 1 (FIELD REPORT)

Project Name:	Mountain Valley Pipeline	S&S Program:	Mountain Valley Pipeline (SS027)
Inspector:	Marshall Willis	Inspection Date:	Thursday, June 26, 2025
Project Contact:	Cory Chalmers Brian Clauto	Project Contact Email:	cory.chalmers@eqt.com brian.clauto@eqt.com
Spread H: Roanoke County	STA 12634+00 – 12665+00 MVP-RO-279.01	Site Conditions:	Dry

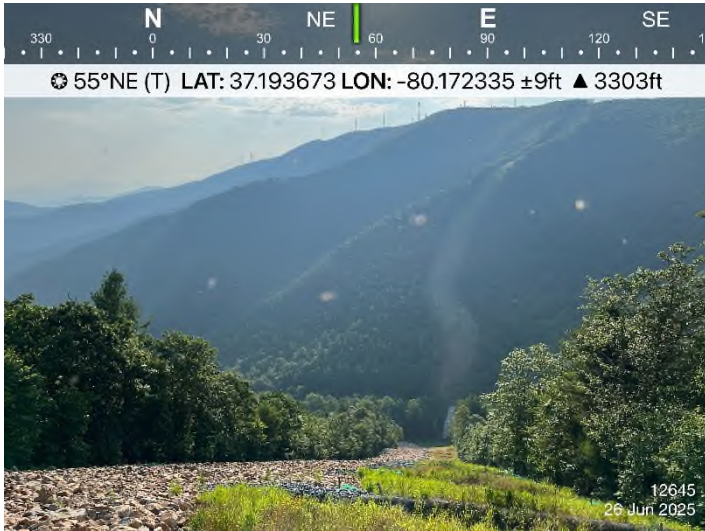
Fig. 1
STA 12645+00: Controls in place and functioning properly.

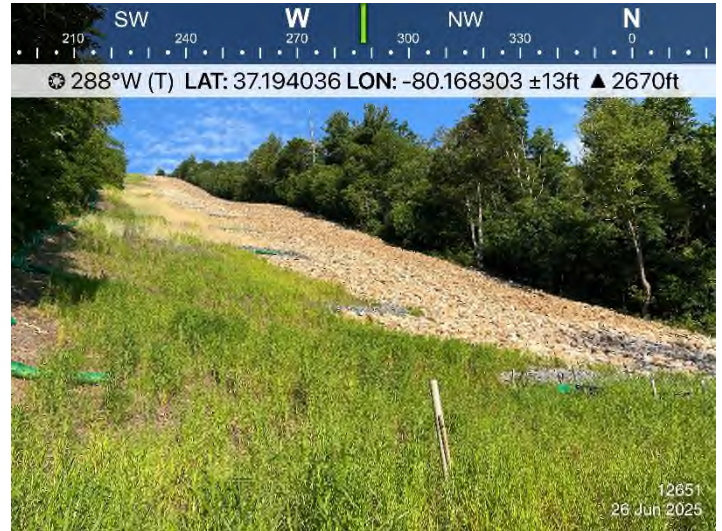
Fig. 2
STA 12651+00: Controls in place and functioning properly.

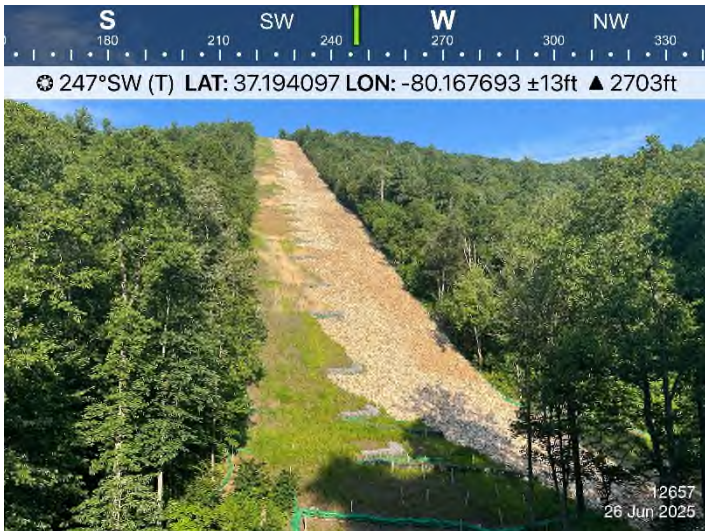
Fig. 3
STA 12657+00: Controls in place and functioning properly.

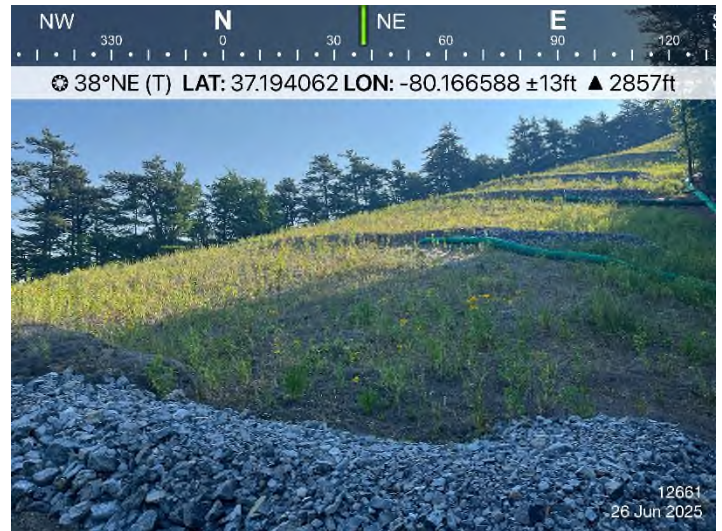
Fig. 4
STA 12661+00: Controls in place and functioning properly.
