## STANDARDS & SPECIFICATIONS SITE INSPECTION REPORT

| Project Name: | Mountain Valley Pipeline | S&S Program: | Mountain Valley Pipeline (SS027) |
| Inspector: | Matthew Grant | Inspection Date: | Wednesday, July 16, 2025 |
| Spread H:<br>Montgomery County | STA 12072-12010<br>MN270, 268.01 | Site Conditions: | Dry |

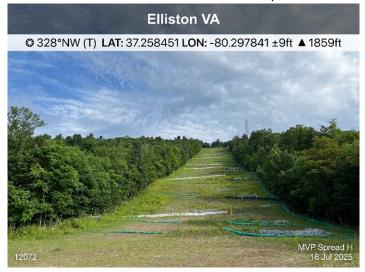
Fig. 1

STA 12072: Stabilization and ECD remains in place.

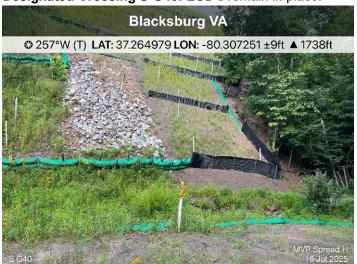
Fig. 2

Designated Crossing S-G40: ECD's remain in place.

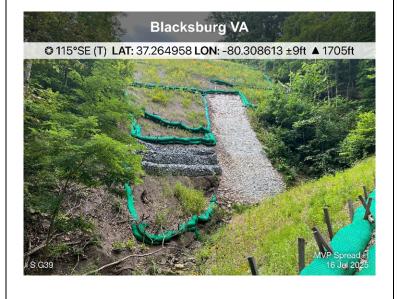
Fig. 3

**Designated Crossing S-G39:** ECD's remain in place.

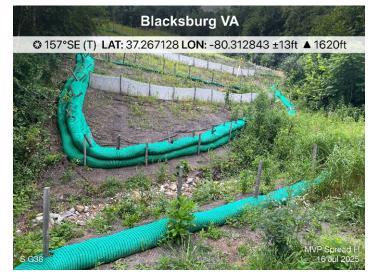
Fig. 4

**Designated Crossing S-G38:** ECD's remain in place.
