COMPLAINT INVESTIGATION REPORT

Project Name:	Mountain Valley Pipeline	Inspector:	Marshall Willis, Matthew Grant
Inspection Date:	Tuesday, July 15, 2025	Project Contact:	Brian Clauto, Cory Chalmers
Spread I: Franklin County	STA 13888+00 – STA 13916+00	Weather:	Wet

Background: This investigation was conducted in response to complaint (IR#: 319764) submitted to PREP on July 14, 2025. The incident describes “heavy stream sedimentation” and “work on the MVP causing heavy red mud to be released to the creek”.

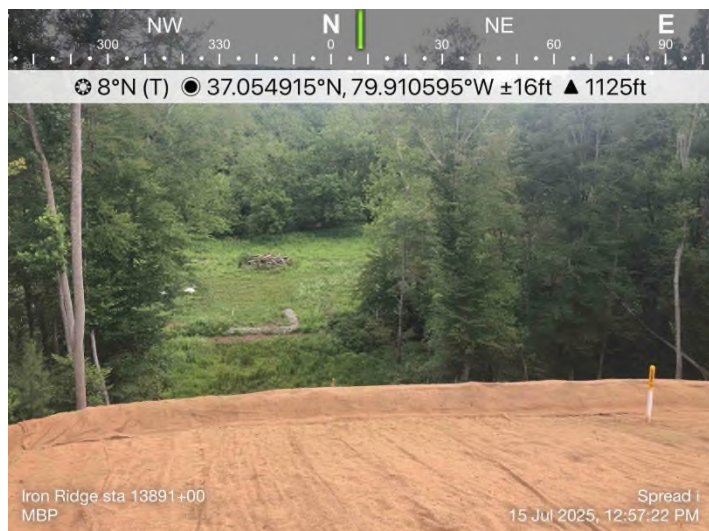
Figure 1: STA 13891+00 – Full length waterbars installed and stabilized with erosion control matting.

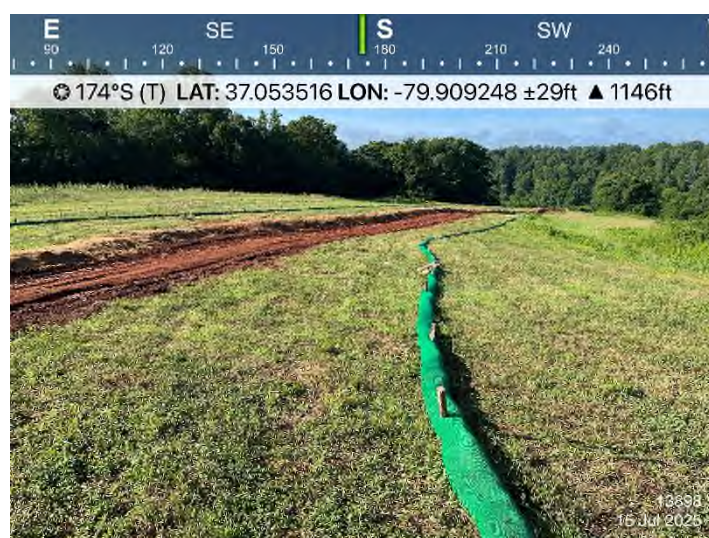
Figure 2: STA 13898+00 – Travel lane installed for access to S-II2 bank repair. Controls in place and functioning properly.

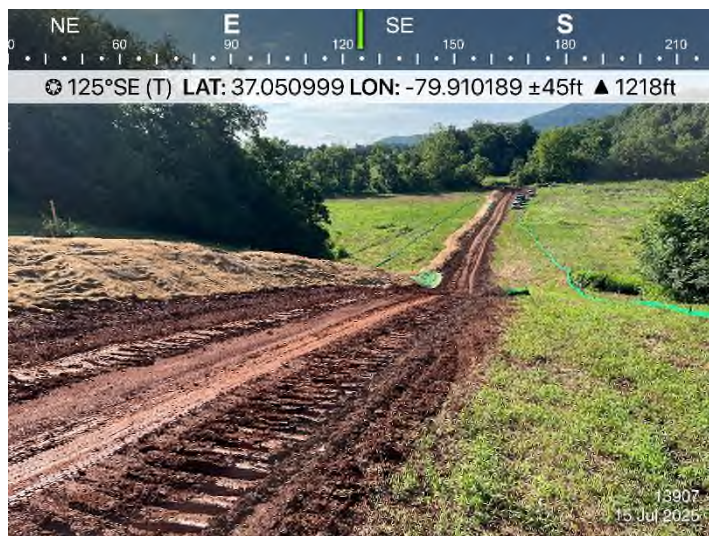
Figure 2: STA 13907+00 – Travel lane installed for access to S-II2 bank repair. Controls in place and functioning properly.

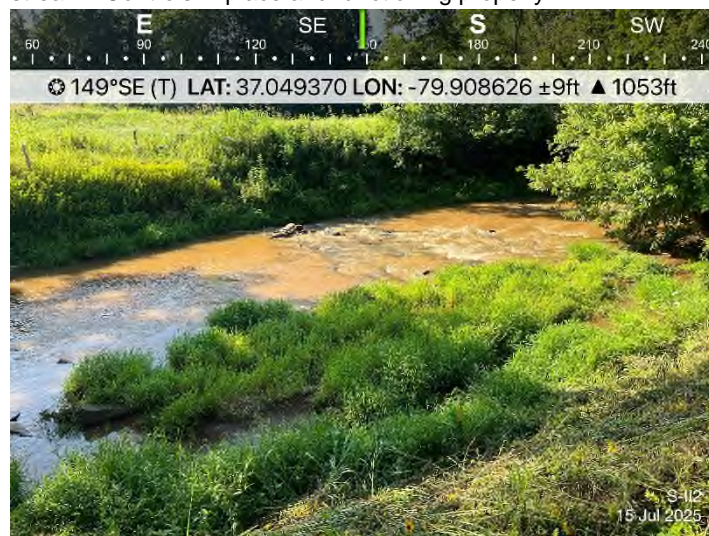
Figure 4: Stream S-II2 – Little Creek at the MVP crossing. No work was being done in the stream. Note turbid condition of the stream. Controls in place and functioning properly.
